ANALYSIS REPORT

BIG BEAR LAKE PROPERTY RENOVATION PROJECT

INSTITUTIONAL DESIGNS AND ARCHITECTURAL SERVICES

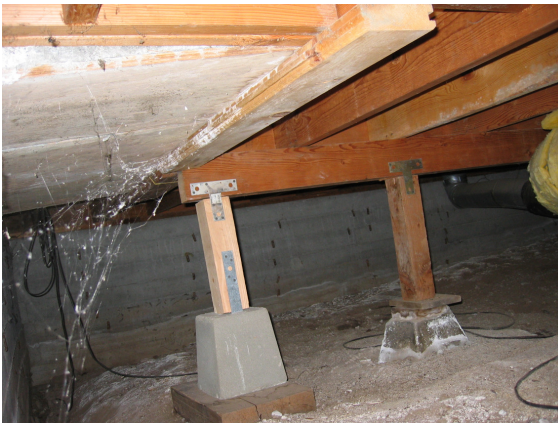
Figure 1: Typical Sub-Floor Construction

The house appears to consist of an original structure with subsequent additions. Judging from the sub-floor construction, the original building appears to be the rear portion of the first floor, bounded by Pantry 108 and Bathroom 114 on the south end and Sitting Room 104 on the north. (Please note that these room designations are per the existing floor layout.) The boundary of this two-story portion is approximately 40 feet by 19.5 feet, supported by a 6-inch thick concrete stem wall foundation. The crawl space beneath the foundation has a clear height that varies between approximately 1'-6" and 2'-6". The sub-floor is constructed of 1x6 straight sheeting supported by 2x6 floor joists spaced at approximately 16 inches on center. The floor joists span between interior 4x4 beams and perimeter 2x6 wood sills atop of the stem walls. The beams are supported on 4x4 wood posts and concrete piers. The 2x6 wood sills appear to be anchored to the stem walls with 1/2" diameter cast-in-place anchor bolts spaced at about 6 feet on center. An additional concrete stem wall segment provides support for the south bearing wall of Sitting Room 104.

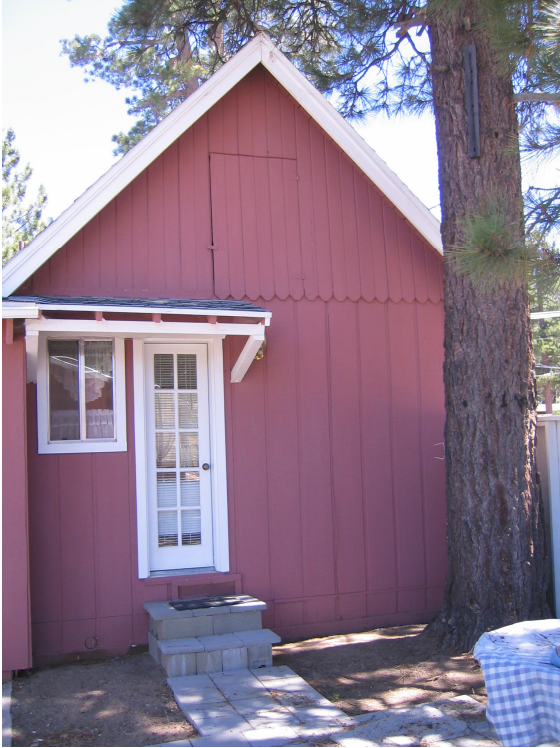
Figure 3: House's South Portion

The house's one-story southernmost portion containing Bedroom 112, Closet 112A and Bathroom 112B (*Figure 3*) appears to have been a separate building at one time. (Please note that these room designations are per the existing floor layout.) Access to the crawl space beneath the sub-floor was not possible since the CMU block stairs at the exterior west door block the access hatch. However, it is reasonable to assume that the construction is similar to that of the original portion of the house. It should be further noted that the presence of perimeter concrete sill walls could not be verified since the combination of siding and 2x pressure treated wood extended down to the soil surface. The gabled roof is likely constructed of 2x rafters that bear directly on the south and north 2x stud walls.

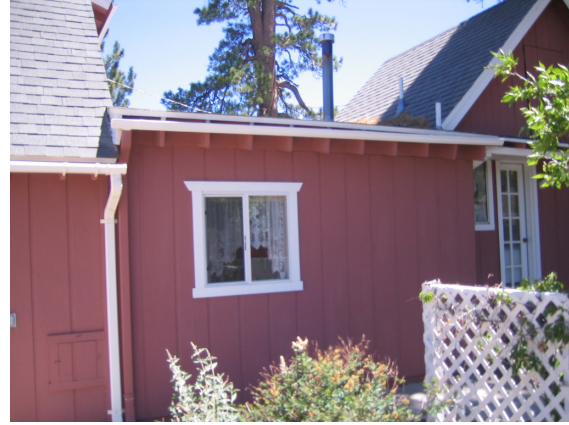
Figure 4: Middle Slab-On-Grade House Addition

The addition that encompasses Kitchen 113 and Living Room 111 (*Figure 4*) is constructed atop a concrete slab-on-grade with 2x stud walls. Please note that these room designations are per the current floor layout. The roof appears to be constructed of plywood sheathing supported by 2x rafters spanning between the east and west exterior bearing walls and a central ridge beam.

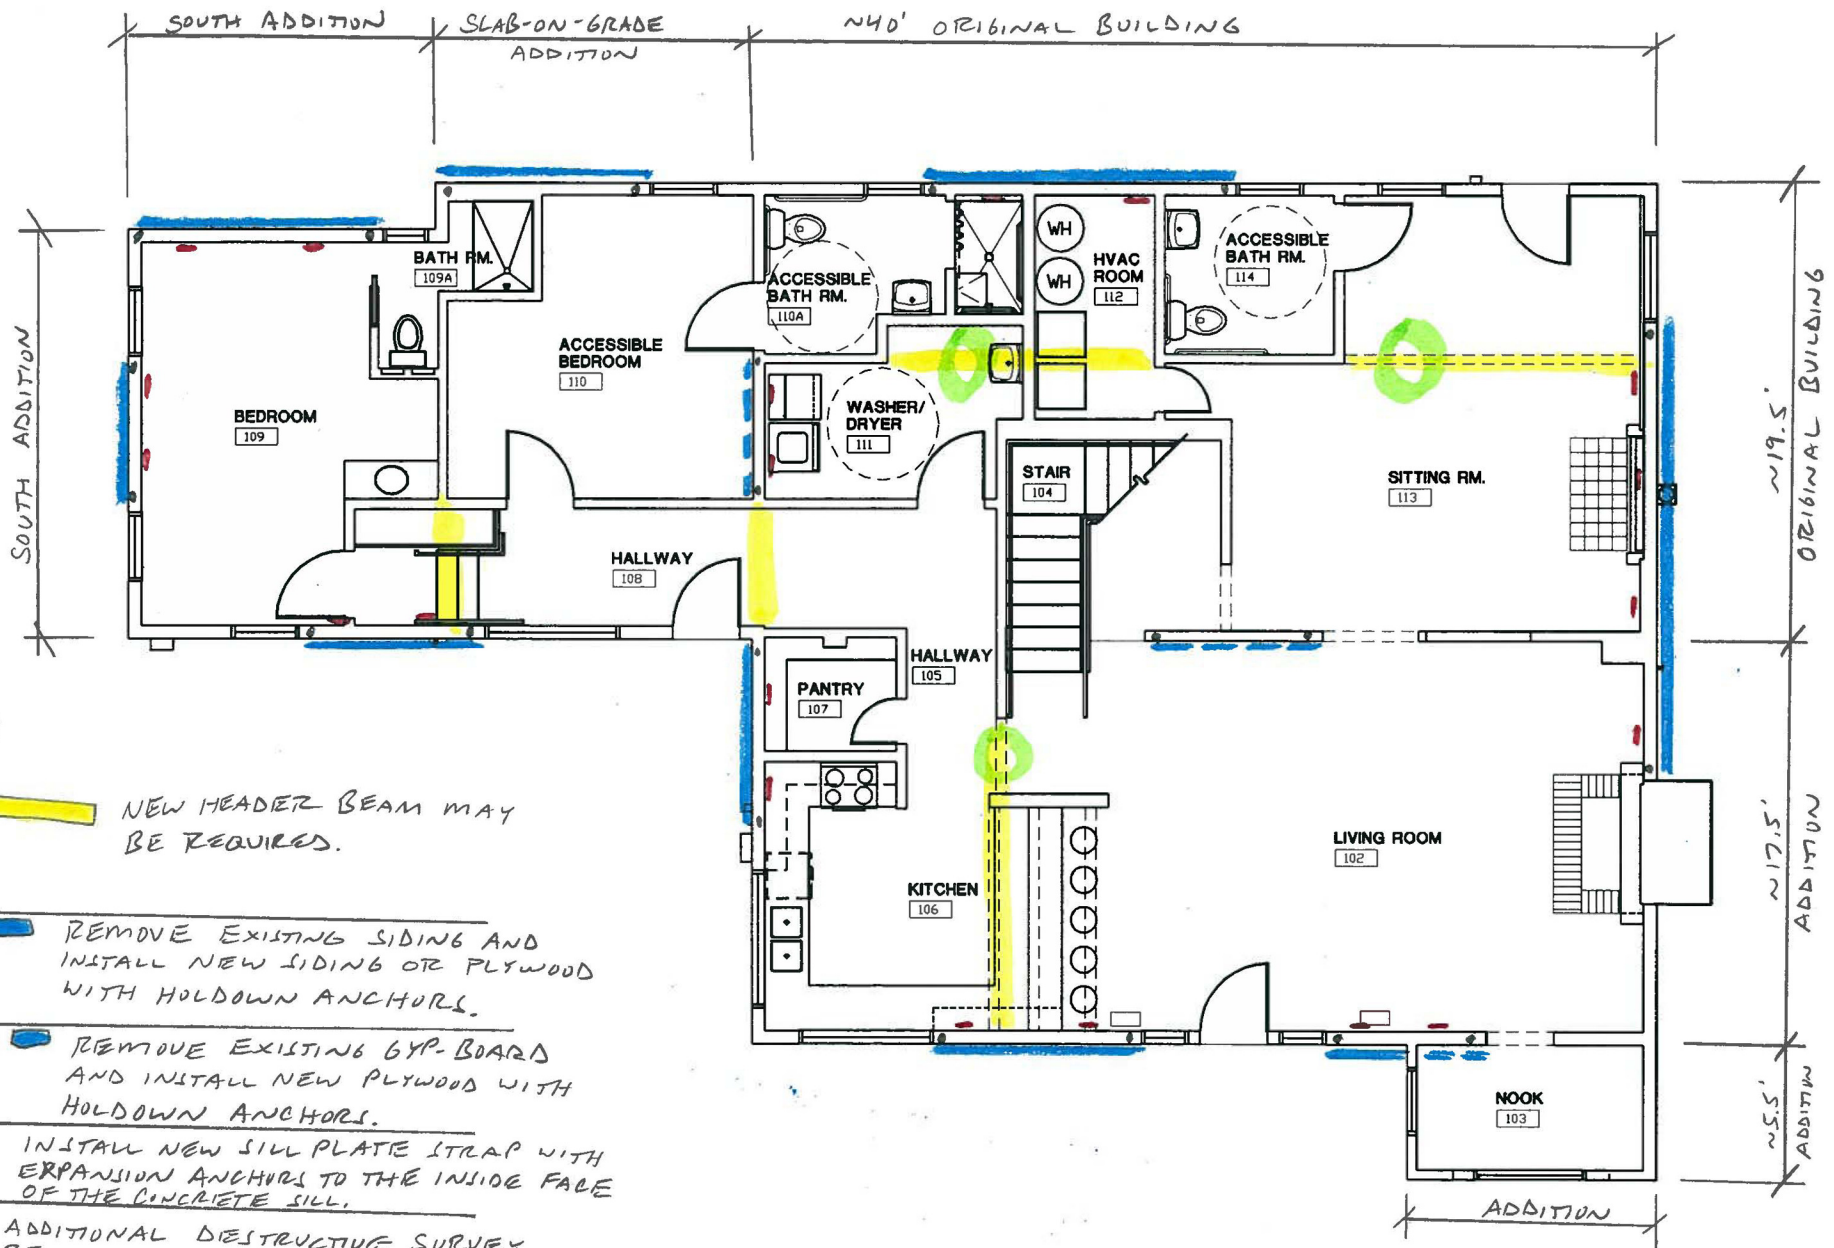
**UC RIVERSIDE BIG BEAR LAKE
 PROPERTY RENOVATION PROJECT
 PROPOSED 1ST FLOOR
 SEISMIC STRENGTHENING
 FIGURE 5**

- The existing vertical lateral force resisting elements could not be determined due to the architectural finishes but are judged to likely be overstressed. Therefore, it is recommended that the existing exterior siding or interior gypsum board be removed in selected locations on both the first and second levels for the installation of plywood sheeting with hold-down anchorage at each end. Additional nailing will also be required through the bottom 2x sills. Please refer to the solid and dashed blue lines in *Figures 5 and 6* below for proposed locations of these new shear walls for the remodel schemes. The blue lines are located on the side of the wall where the plywood sheeting is proposed.

Strip off existing siding and replace with new at identified exterior shear walls = (\$10/ft ²) 30' x 8' at second floor plus 90' x 9' at first floor = 1,050 ft ² x \$10/ft ² =	\$12,000-\$15,000
Strip off existing gypsum board and replace with new plywood & gypsum board at identified interior shear walls = (\$10/ft ²) 10' x 8' at first floor = 80 ft ² x \$10 /ft ² =	\$900-\$1,200
Install hold-down straps at second floor shear walls (6 locations) = 6 x \$100 =	\$700-\$900
Install hold-down anchors at first floor shear walls (19 locations) = 19 x \$250 =	\$5,500-\$6,800
Install 18 gage coil straps where required	\$4,000-\$5,000
Install sill plate anchors at approximately 16 locations (\$200/plate) = 16 x 200 =	\$3,700-\$4,600
TOTAL	\$26,800-\$33,500

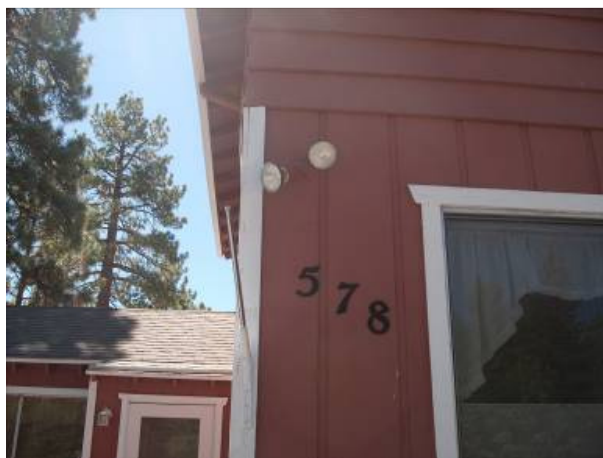
Figure 3: Exterior Lighting

In the back of the building there is a hot tub being served by a 50A disconnect. Entrance doors into the house are each lit with either an incandescent or fluorescent porch light. The drive line is lit by fixtures which are attached to the structure of the building (there are no pole or bollard lights specific to the parking area, see *Figure 3*).

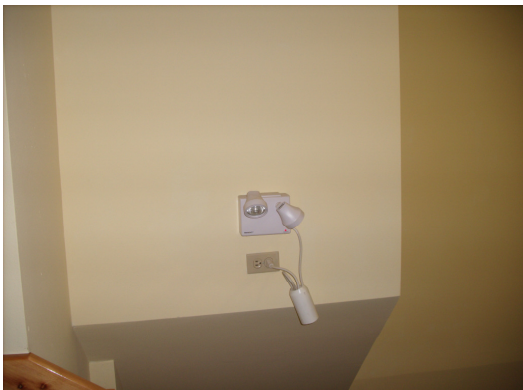
Figure 4: Emergency Light in Stairwell

Existing life safety systems in the house include the emergency light at the stairway and battery powered residential smoke detectors (with audible alarm), located in most rooms of this building (see *Figures 4 and 5*). The smoke detectors are not networked together. There are no visible alarm notification devices (such as strobes).

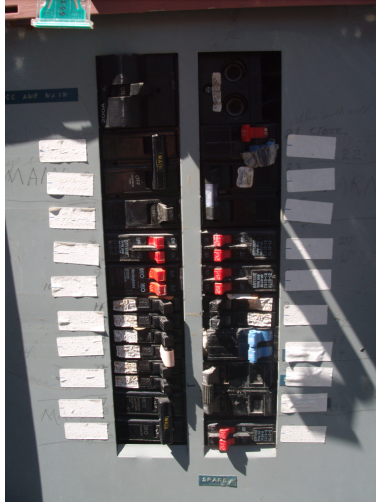
Figure 6: Existing 200A Service Panel

The existing 200A panelboard may be a limiting factor in upgrading the building, although that is unlikely unless significant loads are added (see *Figure 6*). At a minimum, a sub-panel to the existing panel would be recommended to add circuit capacity – it is likely that more circuits will be added during the renovation, and the current panel has no spare circuit space available.

If the mechanical engineer's recommendation is to replace fan coil units with a gas fired furnace, this change will likely reduce the load on the electrical system. This will be offset by the addition of electric range(s) and other additional loads, but overall it appears the service size will be sufficient. However, we have included a line item in the cost estimate section for a new 400A panel – this could be triggered by a significant change to the program as it is currently understood.
