PIERCE HALL IMPROVEMENTS & INTERIOR IMPROVEMENTS

UCR PROJECT NOS. 950511 & 950532

RBB ARCHITECTS INC

11/01/2016

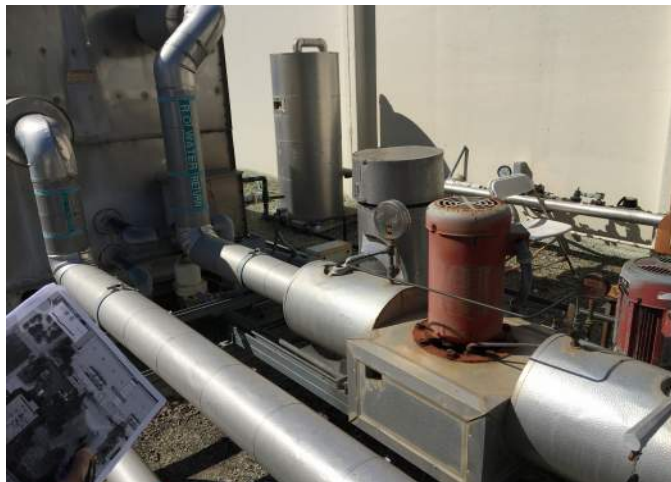
COMMENTS: Abandoned - To be Demolished

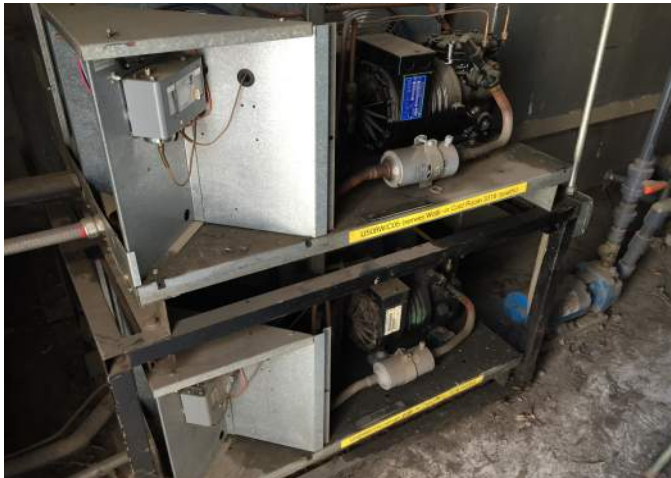
COMMENTS: BTU/hr indicated per as-built drawing. Serve Rm 3316

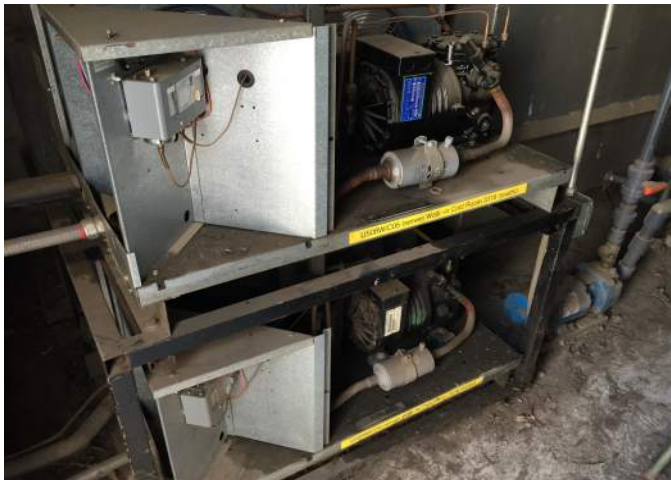
COMMENTS: BTU/hr indicated per as-built drawing. Serve Rm 3316

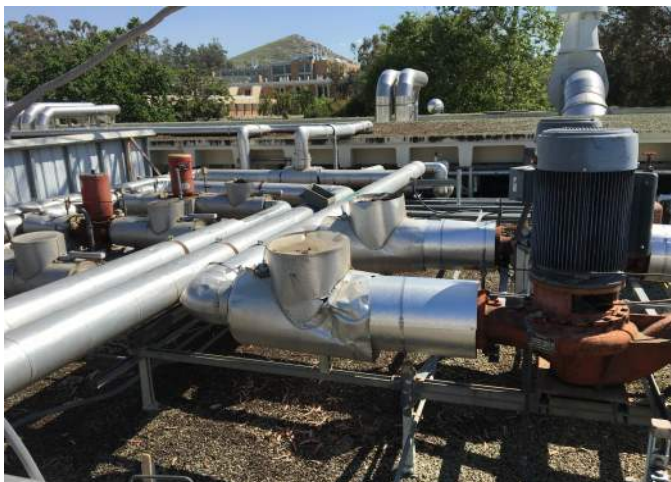
COMMENTS: Abandoned - To be Demolished

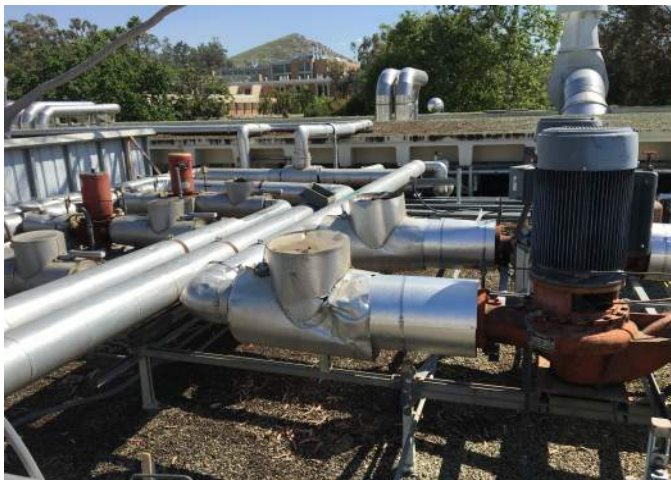
COMMENTS: Abandoned - To be Demolished

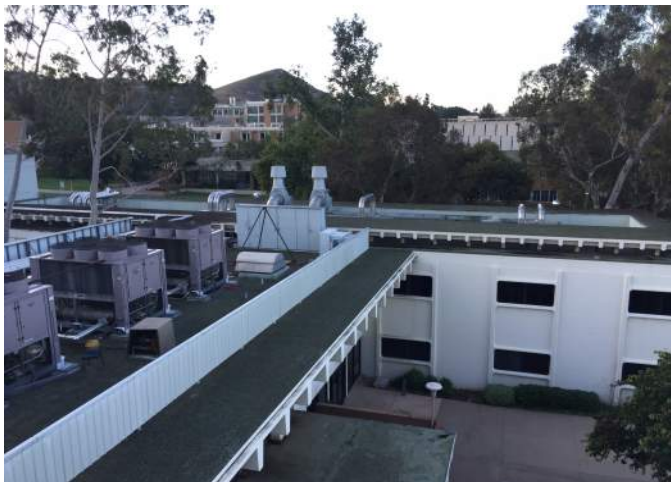
COMMENTS: Abandoned - To be Demolished

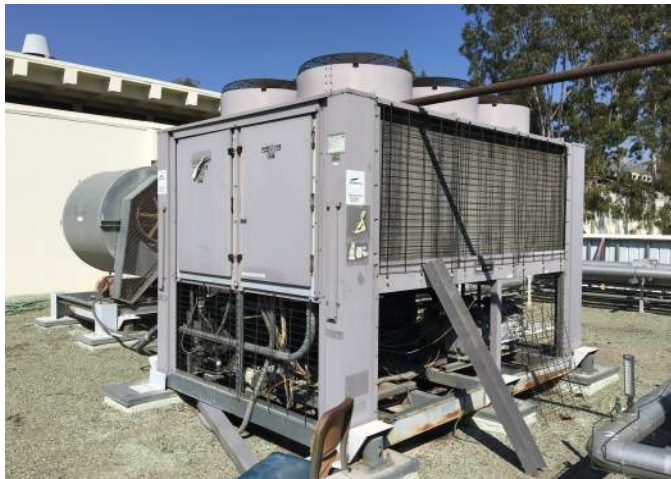
COMMENTS: Abandoned - To be Demolished

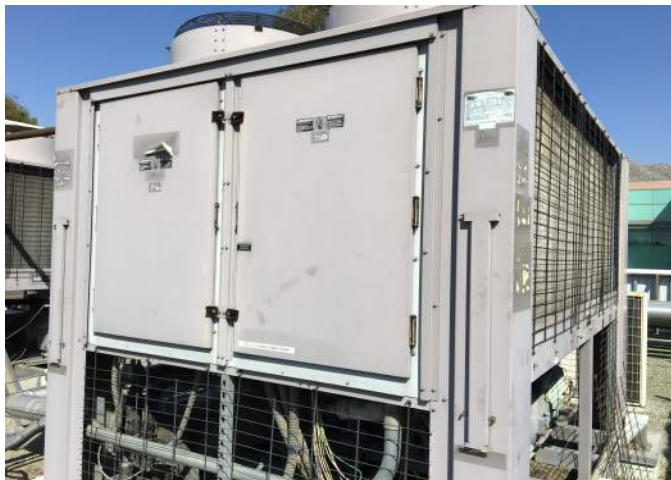
COMMENTS: Abandoned - To be Demolished

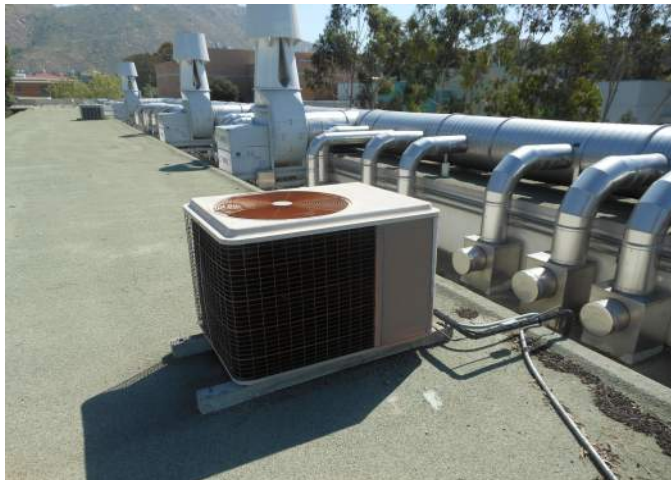
COMMENTS: Abandoned - To be Demolished

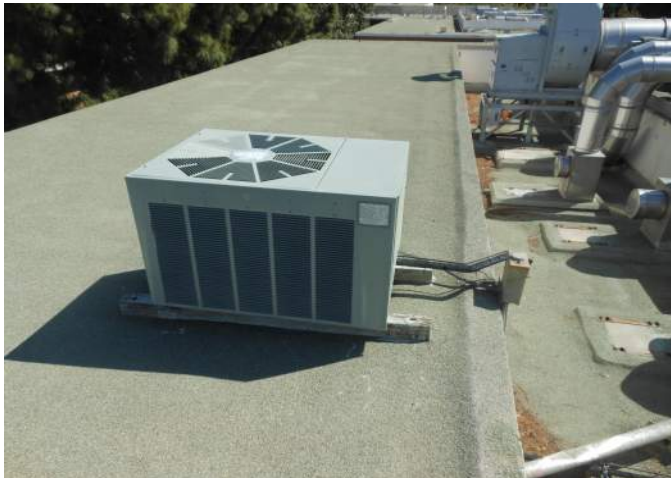
COMMENTS: Abandoned - To be Demolished

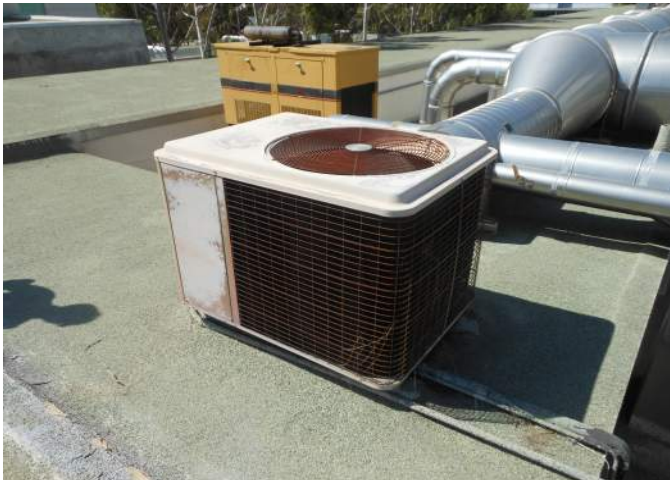
COMMENTS: Abandoned - To be Demolished

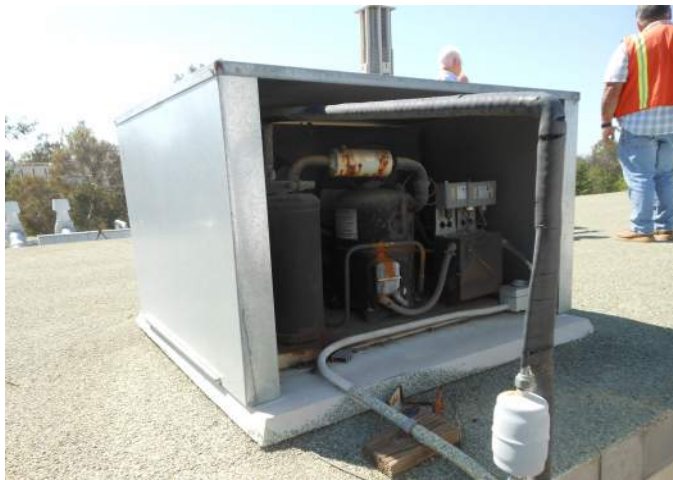
COMMENTS: Abandoned - To be Demolished

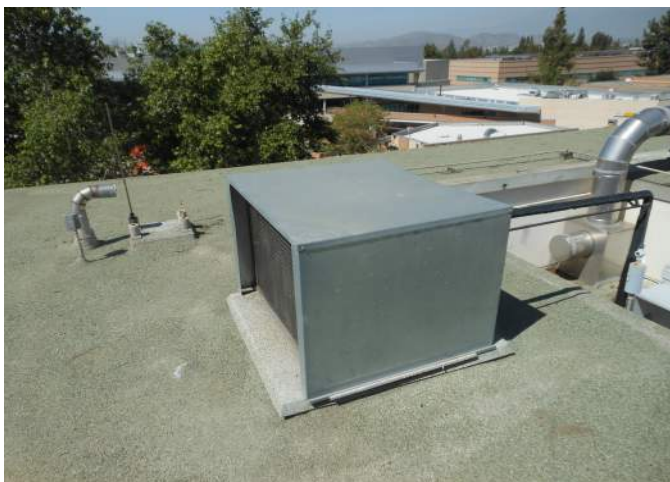
COMMENTS: Abandoned - To be Demolished

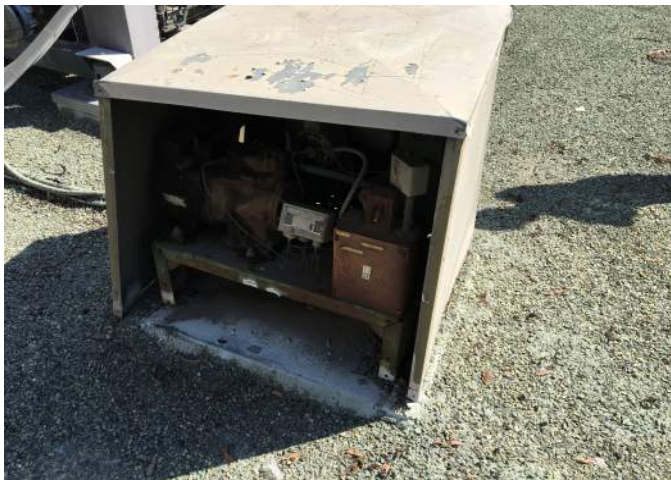
COMMENTS: Abandoned - To be Demolished

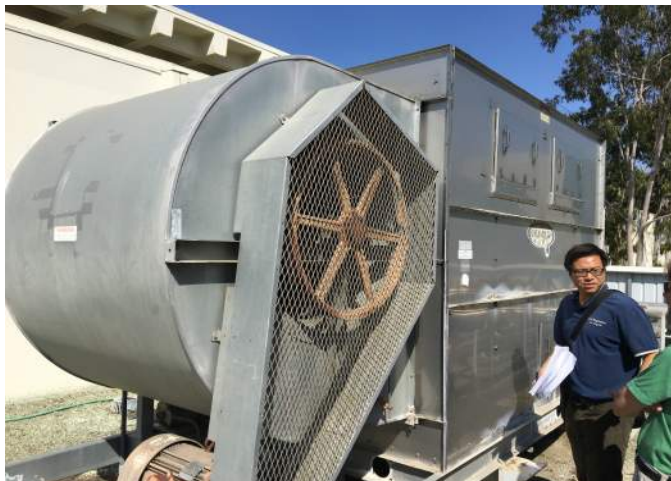
COMMENTS: Abandoned - To be Demolished

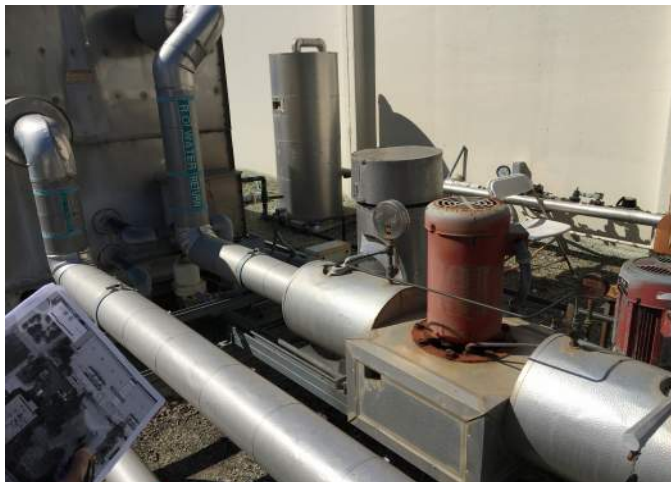
COMMENTS: Abandoned - To be Demolished

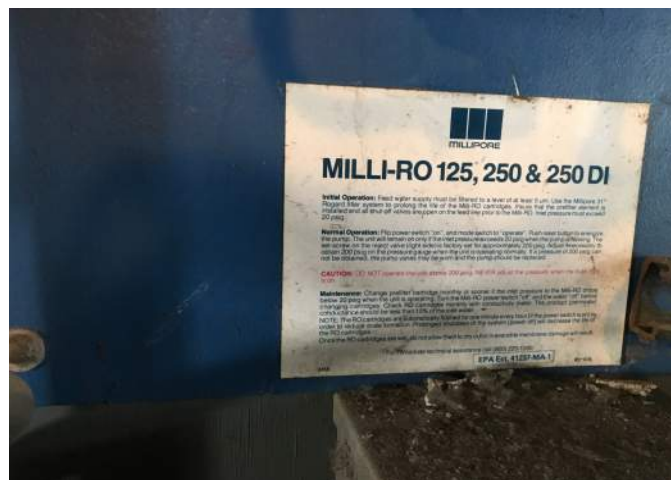
COMMENTS: Capacity indicated per as-built drawing. Observed not working.

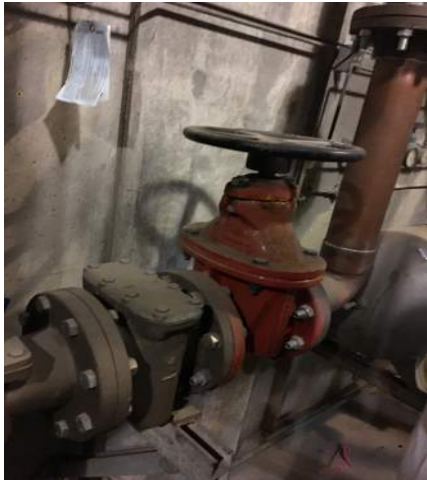
COMMENTS: Per Facility meter does not work.
