ANALYSIS REPORT

BIG BEAR LAKE PROPERTY RENOVATION PROJECT

INSTITUTIONAL DESIGNS AND ARCHITECTURAL SERVICES

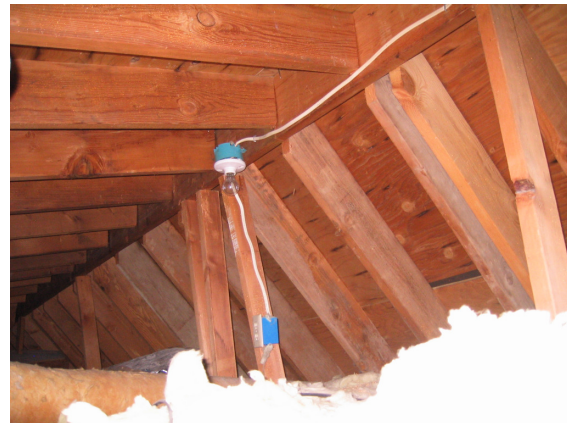
Figure 2: Typical Roof Construction

The second floor is constructed of 1x6 straight sheeting supported by 4x10 joists spaced at 2 feet on center. The floor joists span between the east and west bearing walls of Living Room 102. Floor framing above the Kitchen and Dining Room could not be verified due to the presence of hard ceilings. The roof appears to be constructed of plywood sheeting supported by 2x rafters spanning between bearing walls and ridge beams. King posts shown in *Figure 2* provide support for the ridge beams. The walls appear to be constructed of 2x woods studs.

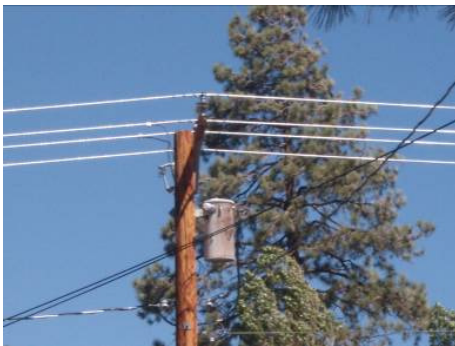
Figure 1: Overhead Transformer

The existing building being studied is a two story house with multiple kitchens, living areas, laundry, and bedrooms on both levels. There is a drive lane out front and a portable hot tub on the back patio. Currently, the electrical loads in the building are served by a 200A, 120/240V single phase panel located on the exterior of the building. The serving utility is Bear Valley Electric and it feeds the building from an overhead transformer approximately 350' from the building – the incoming line is overhead, entering the service panel from overhead via a utility weatherhead (see *Figures 1 and 2*). Electrical loads are mostly typical for a house and include the mechanical equipment, hot tubs, lighting, washers and dryers, convenience receptacles, electric heat lamps and ceiling fans.
