PIERCE HALL IMPROVEMENTS & INTERIOR IMPROVEMENTS

UCR PROJECT NOS. 950511 & 950532

RBB ARCHITECTS INC

11/01/2016

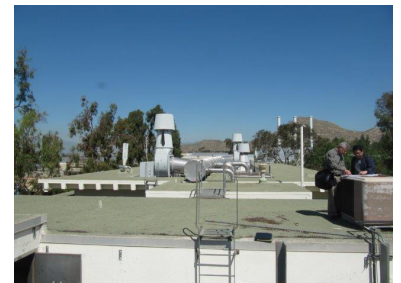
Roof

The existing built-up roofing on rigid insulation has not been replaced since it was originally installed; the seals at the roof drains are cracked and leaks are visible from the labs below.

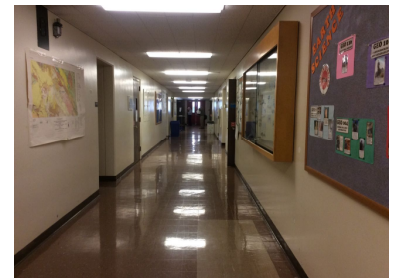
Corridors are 8 foot-wide with concrete shear walls on both sides. Acoustical ceiling tiles are stained and falling in several locations; there are visible signs of water damage on the walls. Existing finishes include vinyl asbestos floor tile with rubber topset base; painted plaster skimcoat walls; acoustical glue-on tile and both semi-recessed and surface mounted fluorescent lighting. Corridor finishes have not been updated and are in poor condition.

*Corridor*

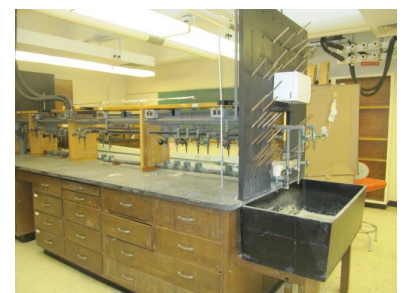
*Typical Research Lab*

wood finish is in poor condition. The floor is damaged throughout. Floor recessed valve boxes are open and the cover treatment is warped. Original wood fume hoods lack lighting and sashes are inoperable.

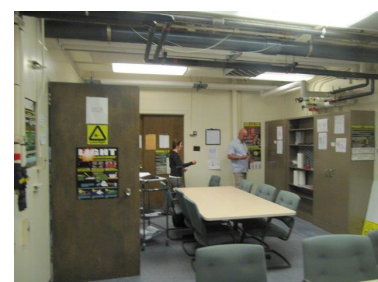
Labs on the second floor north wing house TA Tutoring spaces. These were wet labs that were modified for TA Tutoring purposes; they do not meet the current program needs for wet lab space. All systems are capped off at the walls. The typical spaces have carpet flooring; painted plaster skim-coat walls; ceilings are open to the structure above with fluorescent pendant fixtures. Finishes are in good condition.

Wet Lab Converted to a Conference Room

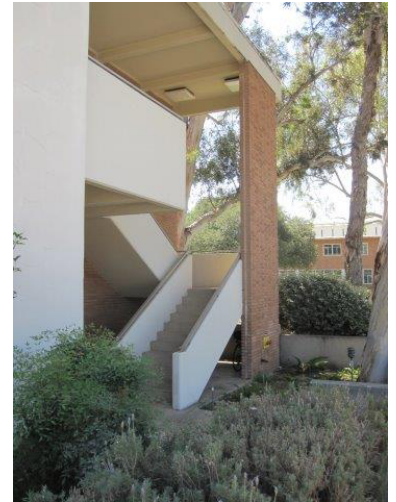
South West Exterior Stairs

The stairs' width and landings meet code. They do not meet the following code requirements:

- 12" handrails extensions beyond the bottom tread + the length of the tread.

- Guardrail opening is maximum 4" and 42" in height.
- Guardrails required where access below the stairs is lower than 7'-6" clearance.
- Maximum riser opening is 4", existing risers are open and are 7" typically,

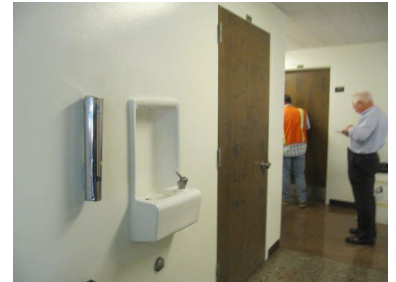
Typical Non-Compliant Drinking Fountain

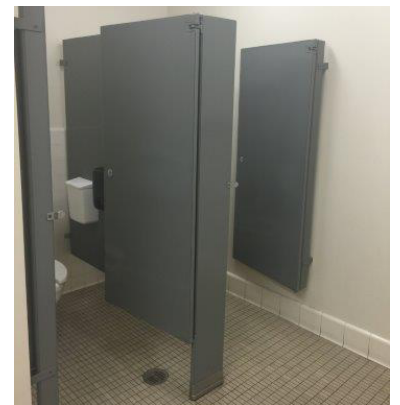
Restrooms do not meet current accessibility codes; clear floor area at the side of doors is insufficient, turnaround spaces and reach for accessories are deficient throughout.

Typical Non-Compliant Water Closet

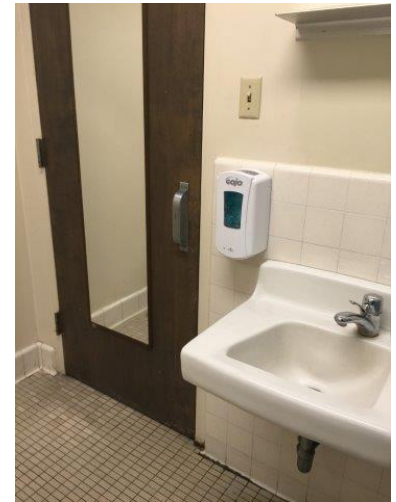
Typical Non-Compliant Restroom Entrance and Accessories

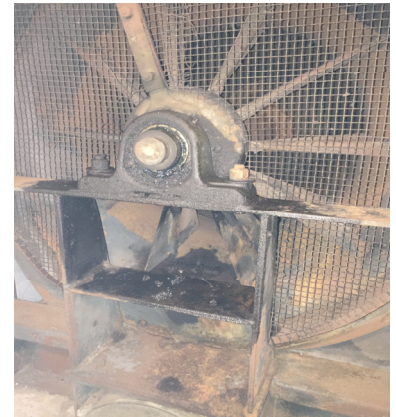
The fan station galvanized steel casing panels, filter bank, fan, motor pulley drive, vibration mounts and structural steel base are in poor condition and exhibit significant corrosion.

Fan station exhibits significant corrosion.

- Demolish existing and provide new built-up Variable Air Volume (VAV) Air Handlers, S-1, S-2 and S-3, including cooling coils, stainless steel drain pans, preheating coils, galvanized steel casing panels, filter banks, fan wall, motors, vibration mounts, associated cooling and heating coils piping hook-ups, dampers, etc.
- Demolish a portion of existing main downstream and upstream ductwork where corrosion is evident and provide new ductwork complete with sound traps.
- Existing ductwork to remain must be cleaned by a qualified contractor specializing in HVAC systems cleaning.

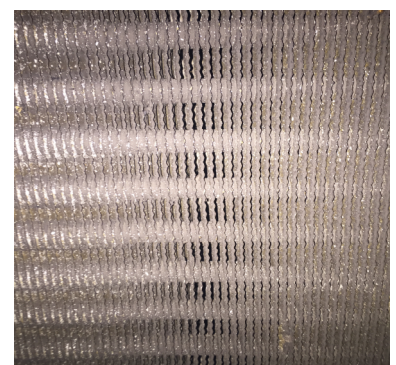
Cooling coils including their casings and drain pans are poor condition.

Cooling and heating coils is in poor condition.

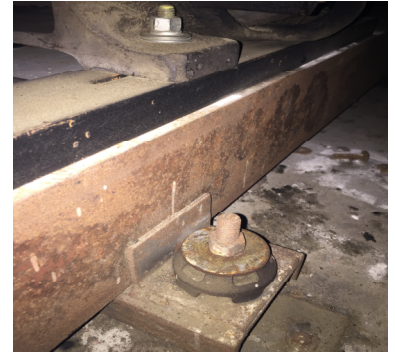
Fan station's vibration mounts and structural base exhibits significant corrosion.

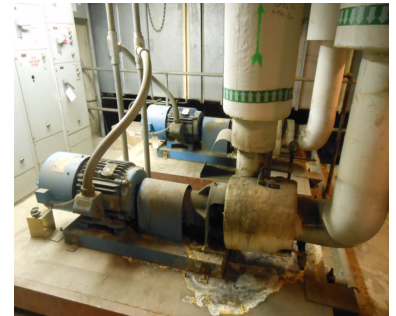
- **Chilled Water Secondary Pumps P-1, P-2, P-5 and P-6:** Chilled water to Fan Station S-1 and S-2 are fed from the campus distribution system through secondary pumps P-1 and P-2. The pumps including its valves are in poor condition. Chilled water to Fan Station S-3 is through secondary pumps P-5 and P-6. The pumps including their valves are in poor condition.
- **Heating Hot Water Recirculating Pumps P-3, P-4, P-7 and P-8:** Heating hot water to Fan Station S-1 and S-2 are fed from the main heating hot water loop through heating hot water recirculating pumps P-3 and P-4. The pumps including their valves are in poor condition.
- **Hot Water Tank T-1** serving the heating hot water system is in poor condition. Heating hot water to Fan Station S-3 is through heating hot water recirculating pumps P-7 and P-8. The pumps including its valves generally are in poor condition.

Chilled water pumps exhibit significant leakage of chilled water

- Demolish existing and provide new (4) chilled water secondary pumps with associated valves, expansion tanks and air separator tanks serving Air Handlers S-1, S-2 and S-3.
- Integrate Variable Speed Drive (VSD) with the new pumps to provide variable chilled water flow into the system.
- Demolish existing and provide new (4) heating hot water recirculating pumps with associated valves, expansion tanks and air separator tanks serving Air Handlers S-1, S-2 and S-3 to ascertain their actual condition.
- Integrate Variable Speed Drive (VSD) with the new pumps to provide variable heating hot water flow into the system.
- Test chilled water piping and heating hot water piping to confirm their actual condition.

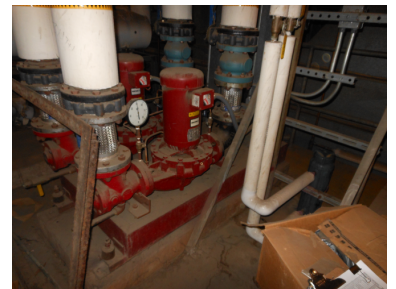
Heating hot water pumps generally are in poor condition

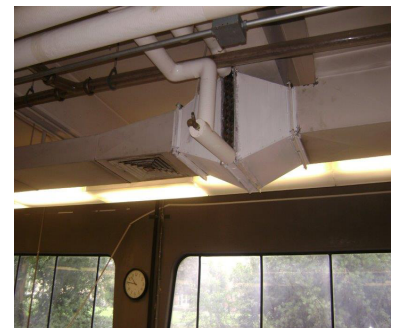
Terminal reheat coils are in fair condition

- Demolish existing supply mixed air flow static pressure dampers and provide new VAV air terminal units for optimum zone air distribution control throughout the building.
- Test existing zone terminal reheat coils to ascertain their actual condition and proper operation.
- Demolish existing ductwork to accommodate new space use, and existing ductwork to remain must be cleaned by a qualified contractor specializing in HVAC systems cleaning.
- Provide new supply air outlets and exhaust ceiling grilles to accommodate proposed new program use.

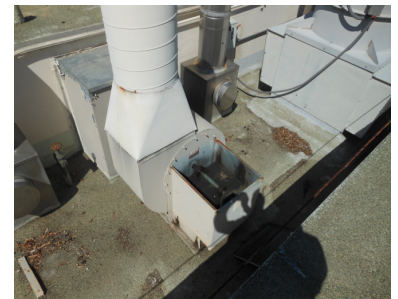
Roof-mounted building exhaust fan is in poor condition

- Demolish the following existing fans and provide new Variable Air Volume (VAV) exhaust fans:
 - Roof-mounted general Exhaust Fans N-14, N-15 and 3424 serving the north wing.
 - Ducted utility Exhaust Fan E-22 serving the basement tunnel.
 - Ducted cabinet type Ventilation Fan V-1 serving the Basement Electrical Room 301.
 - Ducted utility ventilation Fan V-2 serving the basement Electrical Room 304.
- Test the following existing fans to ascertain their actual condition and proper operation. Integrate Variable Speed Drive (VSD) to operate the fans into Variable Air Volume (VAV) system:
 - General Exhaust Fan (EF-1) serving the Central Area.
 - Roof-mounted high stack specialty Fans (EF-2) and (EF-No Tag) with HEPA bag-in/bag-out filters serving the Central Area.
 - Roof mounted Exhaust Fan (EF-3) serving the North Wing.

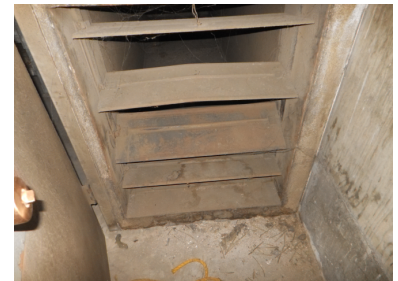
Exhaust fan damper serving the tunnel exhibits significant corrosion

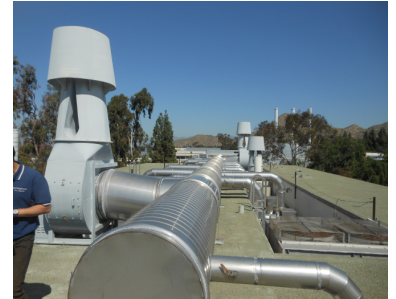
Roof-mounted fume hood exhaust fan and stainless steel manifold are in fair condition

- Prior to Schematic Design Phase, test existing fume hood Exhaust Fans EF-4, EF-5, EF-6, EF-7 EF-8, EF-9, EF-10 and EF-11 to ascertain their actual condition and proper operation.
- Provide phoenix exhaust and supply valves, and integrate Variable Speed Drive (VSD) to operate the fans into Variable Air Volume (VAV) system.

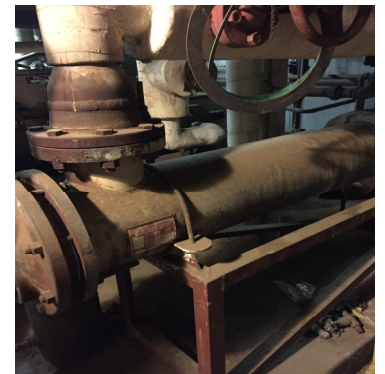
Chilled industrial water is provided for the building laboratories and Pierce Hall Annex through a chilled industrial water heat exchanger located in the basement. Chilled water is fed from the campus chilled water distribution system. The heat exchanger is in poor condition.

Chilled industrial water heat exchanger is in poor condition.

- Demolish existing chilled industrial water system, equipment, piping, valves, etc., located on the roof of the south wing. The system is redundant and has been abandoned.
- Demolish existing and provide new chilled industrial water equipment located in the North Wing Basement – (1) heat exchanger, (2) associated recirculating pumps, (1) expansion tanks, (1) air separators, valves, etc.

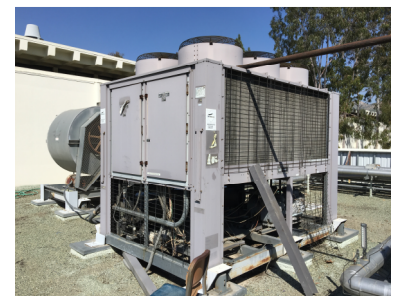
Another chilled industrial water loop is provided on the south wing roof, which is in poor condition and has been abandoned. The loop consist of (3) chillers, (2) chilled water pumps, expansion tank, air separator, valves and piping.

Abandoned air cooled chiller to be demolished previously serving chilled industrial water system.

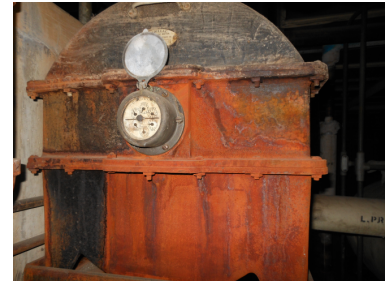
Campus fed High Pressure Steam (HPS 95 psi) steam provides heating to generate medium and low pressure steam for laboratories, still, heating hot water and domestic hot water for the building. High pressure steam is fed to (5) Pressure Reducing Valves **PRV-1, PRV-2, PRV-3, PRV-4 and PRV-5** station. The PRV stations are in poor condition.

PRV station are in poor condition and exhibit major corrosion

- Demolish existing and provide new Pressure Reducing Valve Stations PRV-1, PRV-2, PRV-3, PRV-4 and PRV-5 with associated valves, fittings, condensate return unit CR-1, flash tank T-3, condensate flow meter and steam flow traps.
- Test existing heating hot water heat exchanger HE-1 to ascertain its actual condition and proper operation.
- Test existing high pressure and low pressure steam piping to ascertain their actual condition.

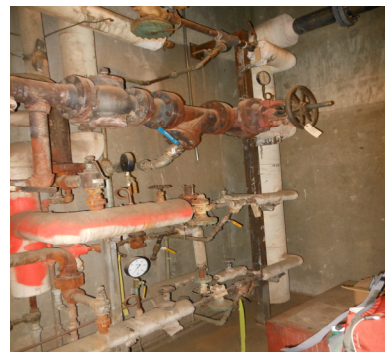
Condensate meter exhibits major corrosion.

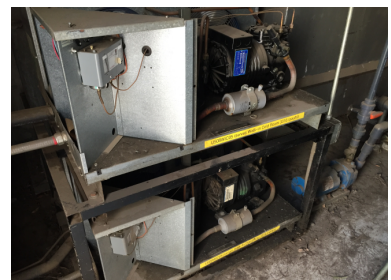
Multiple indoor and outdoor condensing units serving the cold rooms in the building are in poor condition. Depending on whether the Cold Rooms are required by program the design team offers the following recommendations.

Condensing units serving cold rooms are in poor condition.

- Demolish existing outdoor units and indoor units if not required by new space program.
- Test remaining existing outdoor units and indoor units if required to be used for the new program space to ascertain their actual conditions and confirm proper operation.

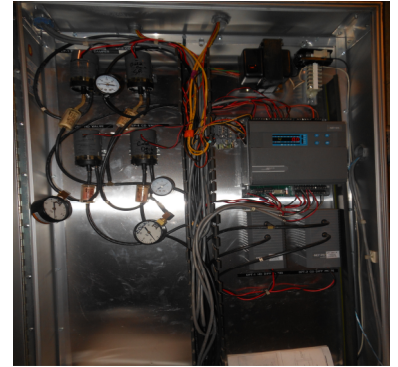
The existing HVAC Control systems are in fair condition. The existing HVAC control system is a combination of Direct Digital Control (DDC) and pneumatic control system.

HVAC pneumatic controls are in fair condition

- Demolish existing remaining pneumatic controls including control Air Tank T-2.
- Upgrade existing HVAC DDC controls and monitoring by providing full DDC control system for optimization of building automation controls. Included in the new HVAC control system is an HVAC control and monitoring from the Campus Central Control Station.

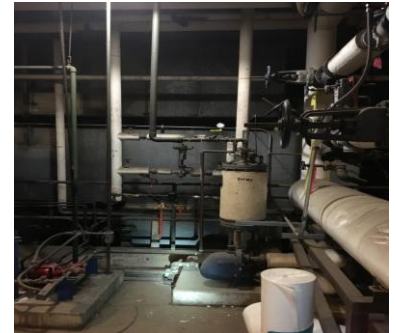
Domestic hot water generator is in poor condition.

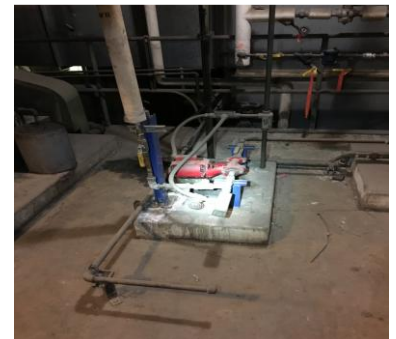
Hot water recirculating pumps are in poor condition.

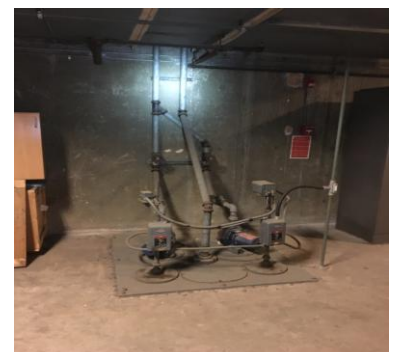
Sump pumps are in poor condition. Typical to all sump pumps

are in poor condition due to its age and had passed its useful service life. The sewer piping system is in fair condition.

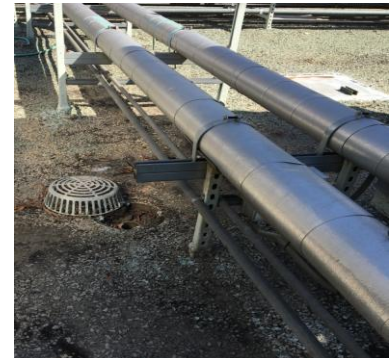
Roof drains are in poor condition.

- Demolish existing and provide new roof drains.
- Test of existing storm water drain piping to ascertain its actual condition

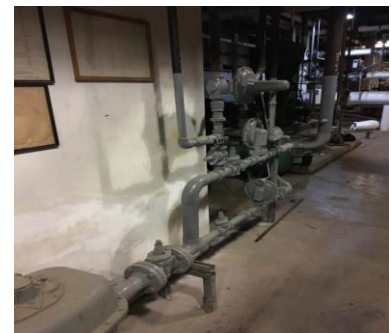
Gas meter assembly is in poor condition.

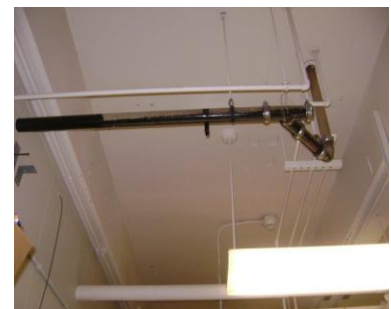
Acid waste resistant piping is in poor condition. There are visible leakages.

- Demolish existing and provide new acid resistant waste piping to serve the laboratories.

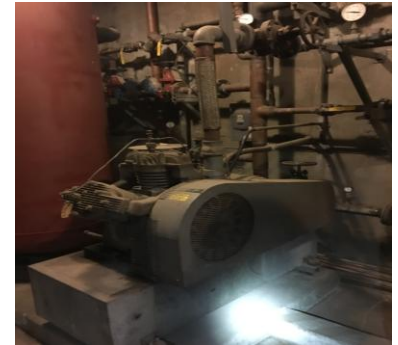
Air compressors are in poor condition.

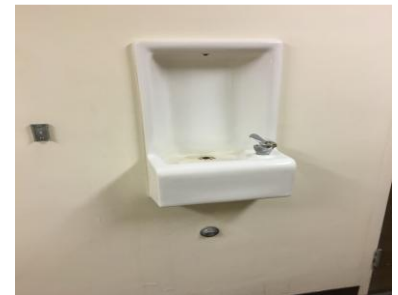
Drinking fountain is not Code compliant

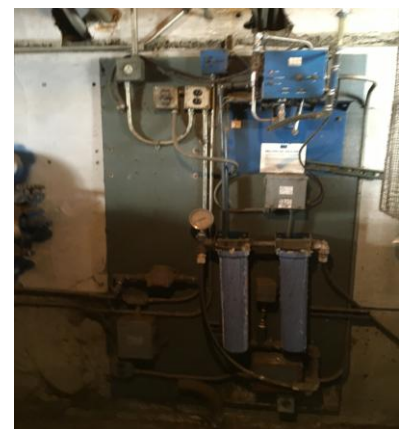
Abandoned distilled water tank

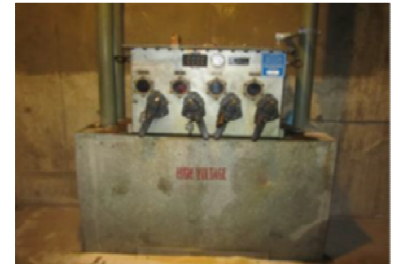
5KV Oil Immersed Switch Unit with Traces of Oil Leakage

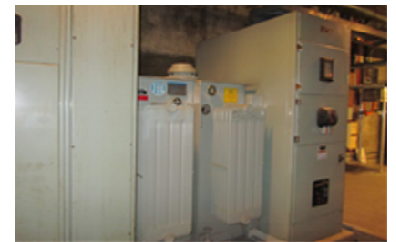
Existing Unit Substation #1 Transformer with PCB

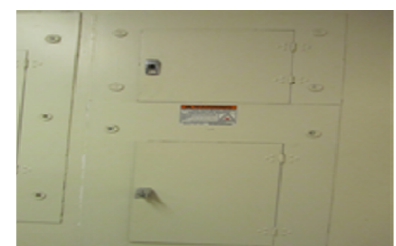
Panelboard With Broken Locks

Replace the panelboards throughout with state of the art panelboards.

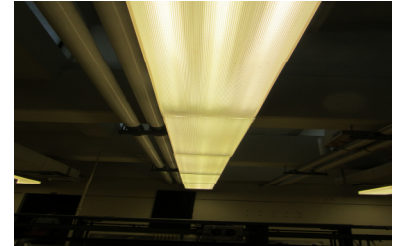
Laboratory lights with discolored lenses

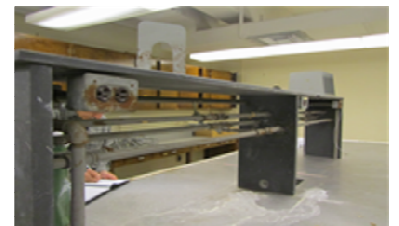
Rusted outlet at Lab bench

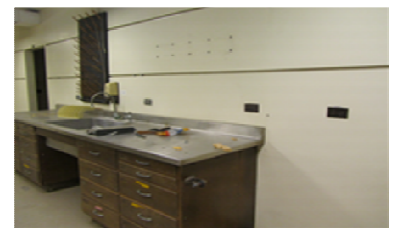
Minimum Receptacles on Laboratory Walls

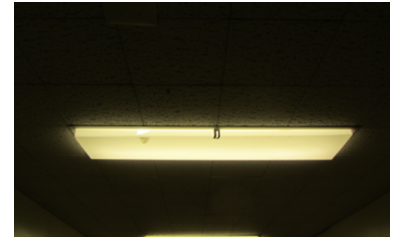
Except for two administrative areas on the first floor, the lighting fixtures in the administration areas and corridors are fluorescent type with prismatic acrylic or opal lenses; they appear to have been installed when the building was built. These have been retrofitted with T-8 lamps. Many of the lenses are falling, others are held in place by temporary means such as metallic brackets attached to the lighting grid to hold the lens in place. Some of the lighting fixtures housing show signs of rust.

*Corridor Light Fixture
Lens Held in Place by Bracket*

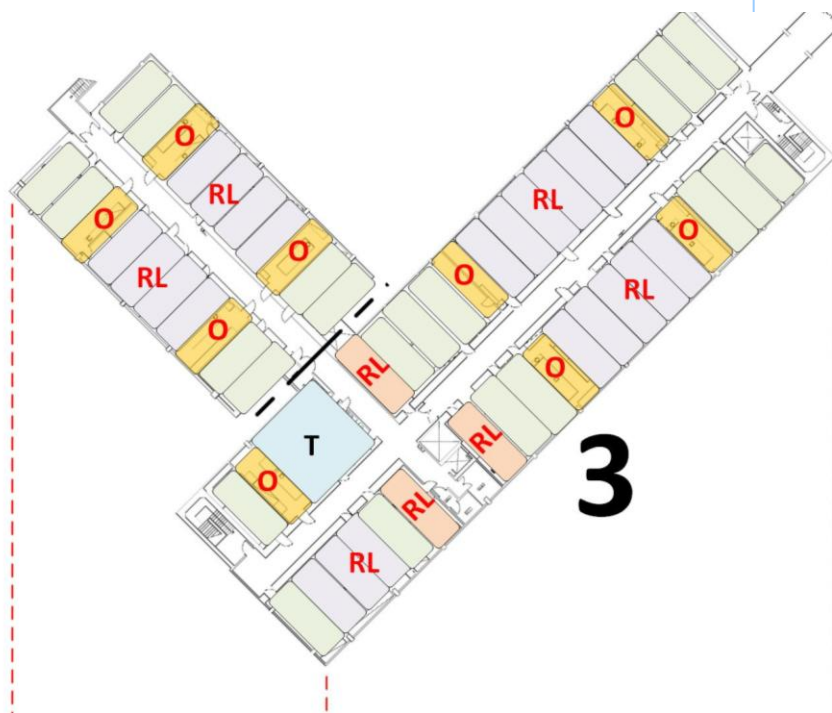
EXISTING
NORTH WING
FLOOR PLAN

EXISTING DOORS
AT CORRIDOR
REQUIRE
MODIFICATIONS
TO STRUCTURAL
CONCRETE
SHEAR WALLS
FOR ADA ACCESS
COMPLIANCE

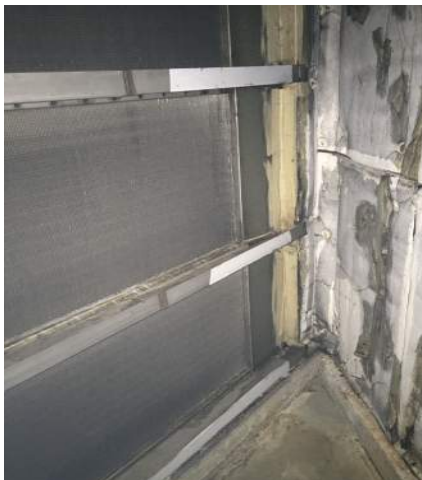
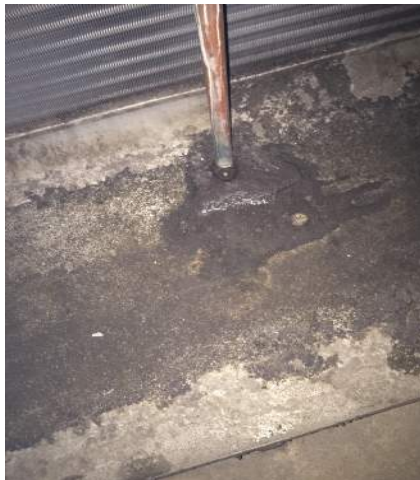
COMPONENT:	CC-1 Cooling Coil
COMPONENT LOCATION:	B05
AREA SERVED:	South Wing
DATE OF INSTALLATION:	1966
REMAINING SERVICE LIFE:	0 yrs
OVERALL SEVERITY:	H
MANUFACTURER:	Trane
SERIAL NO:	
MODEL NO:	Series W
CAPACITY:	243 gpm
ACTION REQUIRED:	Replace
SEVERITY RATING:	High-Poor (Rec. replacement asap)

COMMENTS: Capacity indicated per as-built drawing. Service Life = 20 yrs.

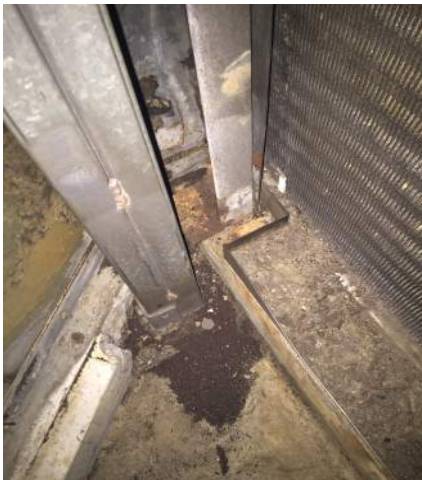
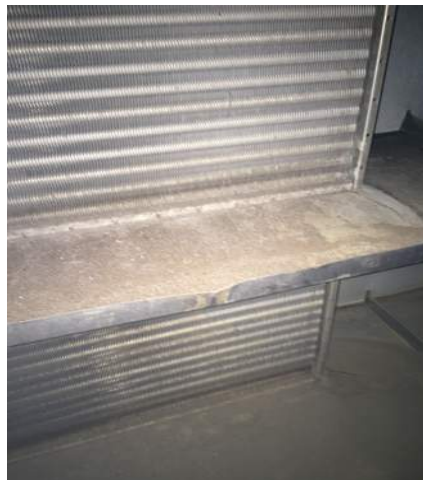
COMPONENT:	CC-2 Cooling Coil
COMPONENT LOCATION:	B02
AREA SERVED:	Central Area
DATE OF INSTALLATION:	1966
REMAINING SERVICE LIFE:	0 yrs
OVERALL SEVERITY:	H
MANUFACTURER:	Trane
SERIAL NO:	
MODEL NO:	Series W
CAPACITY:	816 gpm
ACTION REQUIRED:	Replace
SEVERITY RATING:	High-Poor (Rec. replacement asap)

COMMENTS: Capacity indicated per as-built drawing. Service Life = 20 yrs.

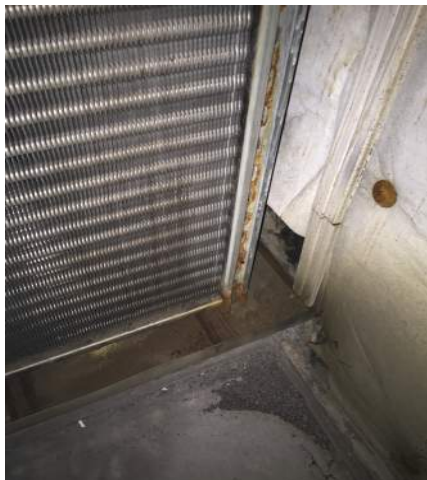
COMPONENT:	CC-3 Cooling Coil
COMPONENT LOCATION:	Basement North Wing
AREA SERVED:	North Wing
DATE OF INSTALLATION:	1966
REMAINING SERVICE LIFE:	0 yrs
OVERALL SEVERITY:	H
MANUFACTURER:	
SERIAL NO:	
MODEL NO:	
CAPACITY:	
ACTION REQUIRED:	Replace
SEVERITY RATING:	High-Poor (Rec. replacement asap)

COMMENTS: No available record drawings. Service Life = 20 yrs.

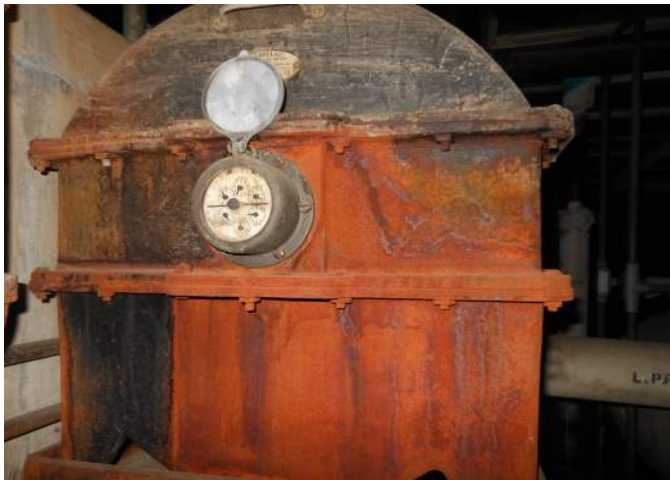
COMPONENT:	Condensate meter
COMPONENT LOCATION:	B02
AREA SERVED:	Steam Syst
DATE OF INSTALLATION:	1966
REMAINING SERVICE LIFE:	0 yrs
OVERALL SEVERITY:	H
MANUFACTURER:	CADILLAC
SERIAL NO:	83663
MODEL NO:	G
CAPACITY:	2"
ACTION REQUIRED:	Replace
SEVERITY RATING:	High-Poor (Rec. replacement asap)

COMMENTS: lbs/hr indicated per as-built drawing. Service Life = 30 yrs.

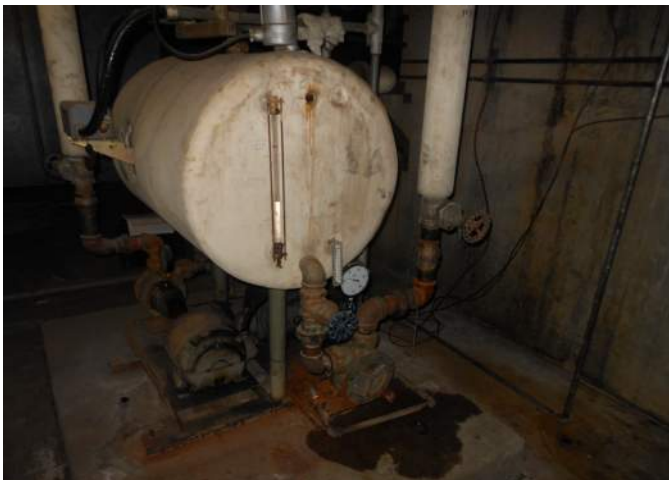
COMPONENT:	CR-1 Cond Ret Unit
COMPONENT LOCATION:	B02
AREA SERVED:	Steam Syst
DATE OF INSTALLATION:	1966
REMAINING SERVICE LIFE:	0 yrs
OVERALL SEVERITY:	H
MANUFACTURER:	
SERIAL NO:	
MODEL NO:	
CAPACITY:	55 gpm ea
ACTION REQUIRED:	Replace
SEVERITY RATING:	High-Poor (Rec. replacement asap)

COMMENTS: GPM indicated per as-built drawing. Service Life = 30 yrs.

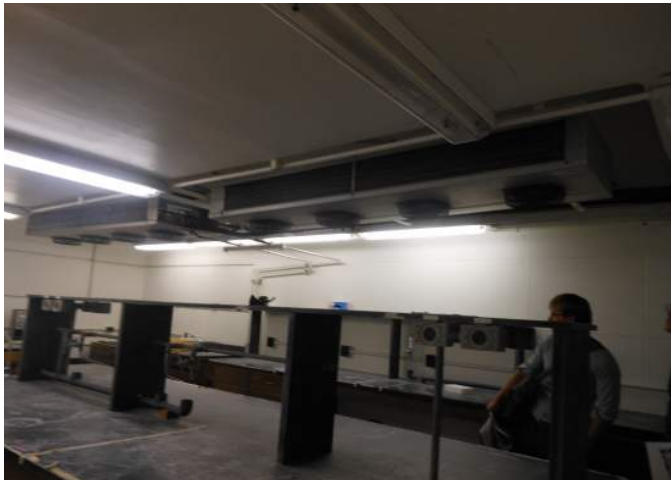
COMPONENT:	CU-1 Cold Rm Clg Unit
COMPONENT LOCATION:	Cold Rm
AREA SERVED:	Cold Room
DATE OF INSTALLATION:	
REMAINING SERVICE LIFE:	5-10 yrs
OVERALL SEVERITY:	
MANUFACTURER:	RUSSELL
SERIAL NO:	
MODEL NO:	FL46-180
CAPACITY:	18,000 BTU/hr
ACTION REQUIRED:	No Action Req'd
SEVERITY RATING:	Med.-Fair (Rec. to replace on next failure)

COMMENTS: BTU/hr indicated per as-built drawing. Serve Rm 3418

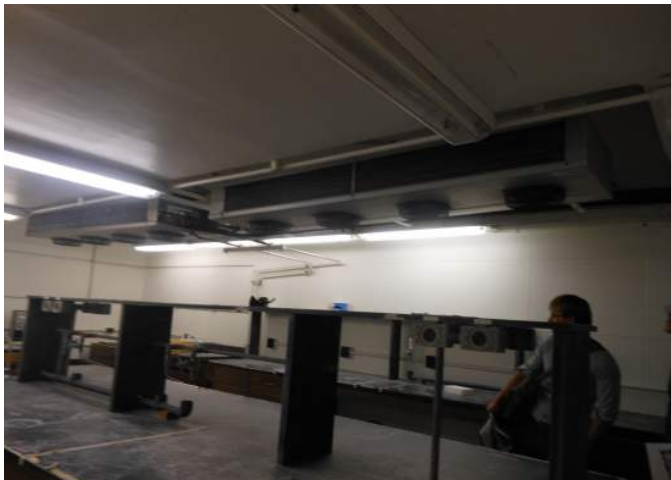
COMPONENT:	CU-2 Cold Rm Clg Unit
COMPONENT LOCATION:	Cold Rm
AREA SERVED:	Cold Room
DATE OF INSTALLATION:	
REMAINING SERVICE LIFE:	5-10 yrs
OVERALL SEVERITY:	
MANUFACTURER:	RUSSELL
SERIAL NO:	
MODEL NO:	FL46-180
CAPACITY:	18,000 BTU/hr
ACTION REQUIRED:	No Action Req'd
SEVERITY RATING:	Med.-Fair (Rec. to replace on next failure)

COMMENTS: BTU/hr indicated per as-built drawing. Serve Rm 3418

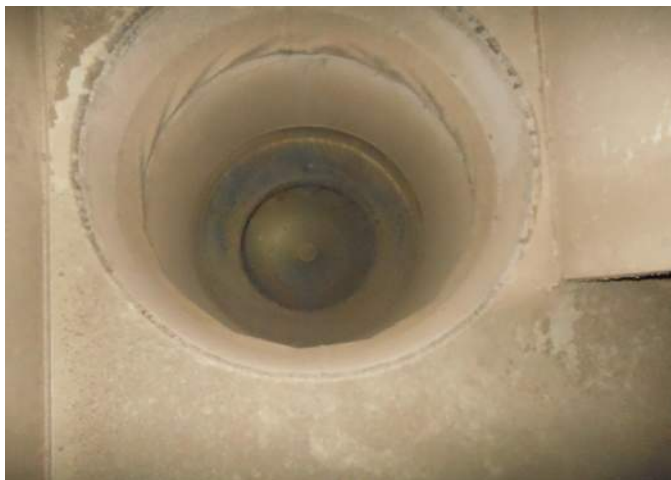
COMPONENT:	E-22 Fan
COMPONENT LOCATION:	B05
AREA SERVED:	Tunnel
DATE OF INSTALLATION:	1966
REMAINING SERVICE LIFE:	0 yrs
OVERALL SEVERITY:	H
MANUFACTURER:	American St.
SERIAL NO:	
MODEL NO:	
CAPACITY:	6,700 CFM
ACTION REQUIRED:	Replace
SEVERITY RATING:	High-Poor (Rec. replacement asap)

COMMENTS: Capacity indicated per as-built drawing. Service Life = 25 yrs.

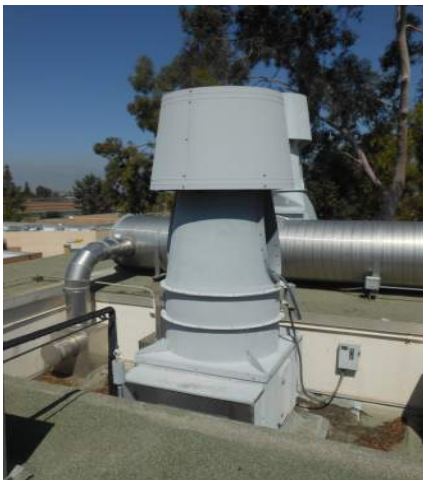
COMPONENT:	EF-1 exhaust fan
COMPONENT LOCATION:	Roof Central Area
AREA SERVED:	General exhaust
DATE OF INSTALLATION:	2000
REMAINING SERVICE LIFE:	5-10 yrs
OVERALL SEVERITY:	M
MANUFACTURER:	MK Plastic
SERIAL NO:	
MODEL NO:	
CAPACITY:	
ACTION REQUIRED:	Repair
SEVERITY RATING:	Med.-Fair (Rec. to replace on next failure)

COMMENTS: No available record drawings. Service Life = 25 yrs.

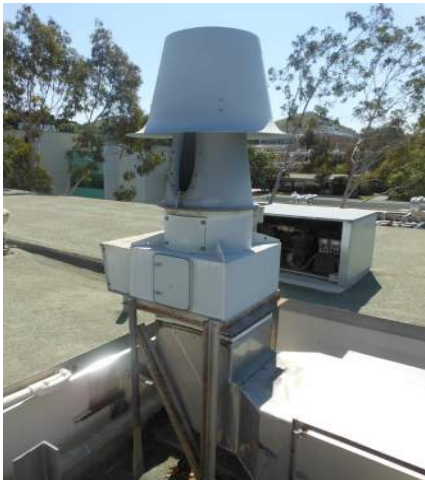
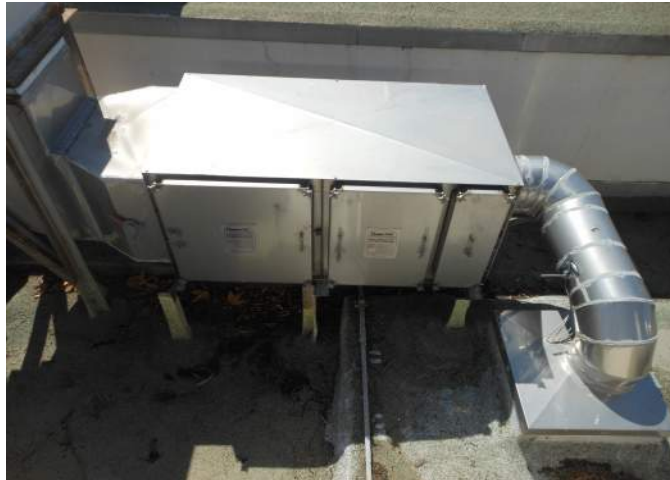
COMPONENT:	EF-2 specialty exhaust
COMPONENT LOCATION:	Roof Central Area
AREA SERVED:	Specialty exhaust
DATE OF INSTALLATION:	2000
REMAINING SERVICE LIFE:	5-10 yrs
OVERALL SEVERITY:	M
MANUFACTURER:	MK Plastic
SERIAL NO:	
MODEL NO:	
CAPACITY:	
ACTION REQUIRED:	Repair
SEVERITY RATING:	Med.-Fair (Rec. to replace on next failure)

COMMENTS: No available record drawings. Service Life = 25 yrs.

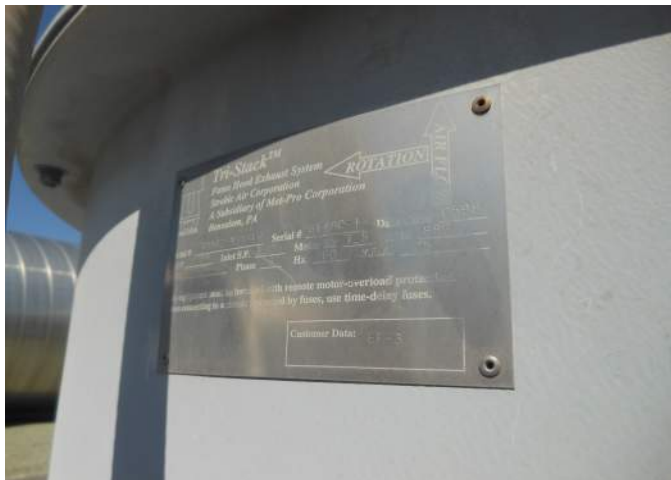
COMPONENT:	EF-3 exhaust fan
COMPONENT LOCATION:	Roof North Wing
AREA SERVED:	General exhaust
DATE OF INSTALLATION:	2000
REMAINING SERVICE LIFE:	5-10 yrs
OVERALL SEVERITY:	M
MANUFACTURER:	Tri-Stack
SERIAL NO:	6118C-1
MODEL NO:	T20025 NSTSFR
CAPACITY:	8,500
ACTION REQUIRED:	Repair
SEVERITY RATING:	Med.-Fair (Rec. to replace on next failure)

COMMENTS: No available record drawings. Service Life = 25 yrs.

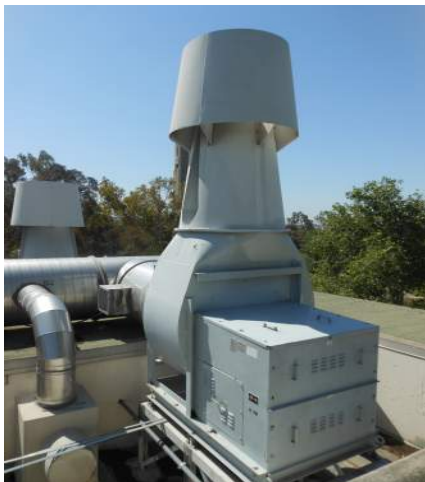
COMPONENT:	EF-4 fume exhaust
COMPONENT LOCATION:	Roof Central Area
AREA SERVED:	Fume exhaust
DATE OF INSTALLATION:	2000
REMAINING SERVICE LIFE:	5-10 yrs
OVERALL SEVERITY:	M
MANUFACTURER:	MK Plastic
SERIAL NO:	
MODEL NO:	
CAPACITY:	
ACTION REQUIRED:	Replace
SEVERITY RATING:	Med.-Fair (Rec. to replace on next failure)

COMMENTS: No available record drawings. Service Life = 25 yrs.

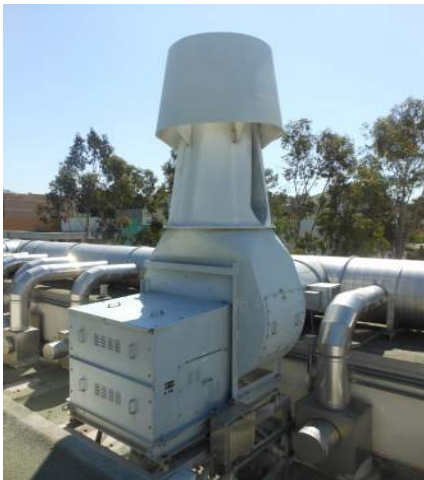
COMPONENT:	EF-5 fume exhaust
COMPONENT LOCATION:	Roof Central Area
AREA SERVED:	Fume exhaust
DATE OF INSTALLATION:	2000
REMAINING SERVICE LIFE:	5-10 yrs
OVERALL SEVERITY:	M
MANUFACTURER:	MK Plastic
SERIAL NO:	
MODEL NO:	
CAPACITY:	
ACTION REQUIRED:	Replace
SEVERITY RATING:	Med.-Fair (Rec. to replace on next failure)

COMMENTS: No available record drawings. Service Life = 25 yrs.

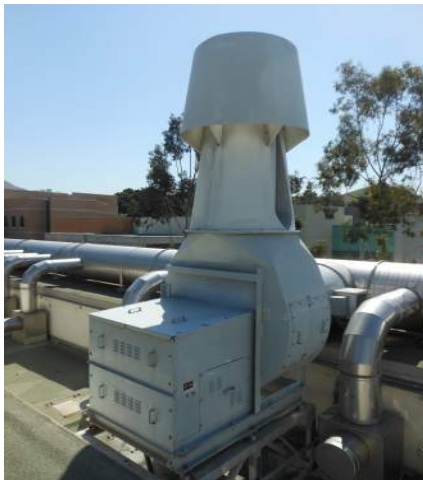
COMPONENT:	EF-6 fume exhaust
COMPONENT LOCATION:	Roof Central Area
AREA SERVED:	Fume exhaust
DATE OF INSTALLATION:	2000
REMAINING SERVICE LIFE:	5-10 yrs
OVERALL SEVERITY:	M
MANUFACTURER:	MK Plastic
SERIAL NO:	
MODEL NO:	
CAPACITY:	
ACTION REQUIRED:	Replace
SEVERITY RATING:	Med.-Fair (Rec. to replace on next failure)

COMMENTS: No available record drawings. Service Life = 25 yrs.

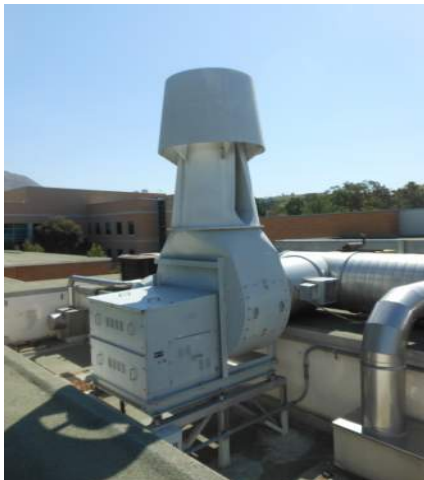
COMPONENT:	EF-7 fume exhaust
COMPONENT LOCATION:	Roof Central Area
AREA SERVED:	Fume exhaust
DATE OF INSTALLATION:	2000
REMAINING SERVICE LIFE:	5-10 yrs
OVERALL SEVERITY:	M
MANUFACTURER:	MK Plastic
SERIAL NO:	
MODEL NO:	
CAPACITY:	
ACTION REQUIRED:	Replace
SEVERITY RATING:	Med.-Fair (Rec. to replace on next failure)

COMMENTS: No available record drawings. Service Life = 25 yrs.

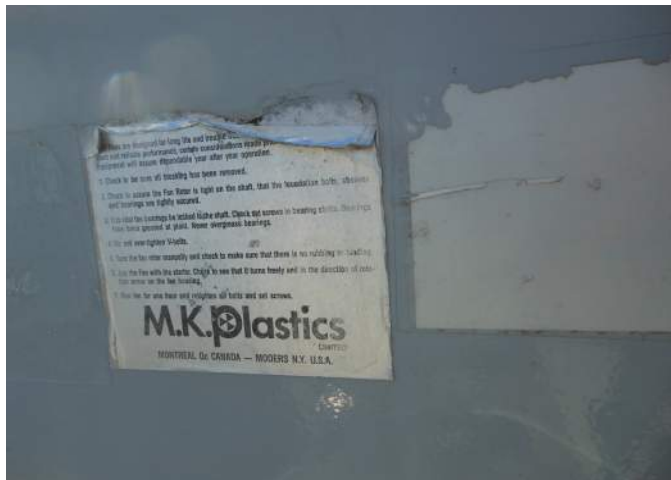
COMPONENT:	EF-8 fume exhaust
COMPONENT LOCATION:	Roof North Wing
AREA SERVED:	Fume exhaust
DATE OF INSTALLATION:	2000
REMAINING SERVICE LIFE:	5-10 yrs
OVERALL SEVERITY:	M
MANUFACTURER:	MK Plastic
SERIAL NO:	
MODEL NO:	
CAPACITY:	
ACTION REQUIRED:	Replace
SEVERITY RATING:	Med.-Fair (Rec. to replace on next failure)

COMMENTS: No available record drawings. Service Life = 25 yrs.

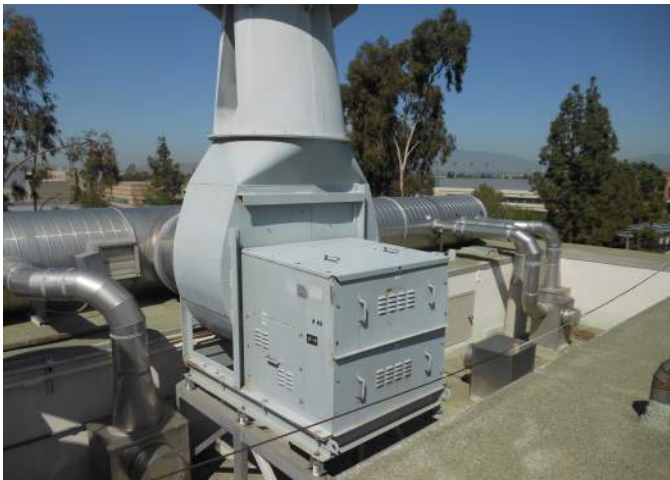
COMPONENT:	EF-9 fume exhaust
COMPONENT LOCATION:	Roof North wing
AREA SERVED:	Fume exhaust
DATE OF INSTALLATION:	2000
REMAINING SERVICE LIFE:	5-10 yrs
OVERALL SEVERITY:	M
MANUFACTURER:	MK Plastic
SERIAL NO:	
MODEL NO:	
CAPACITY:	
ACTION REQUIRED:	Replace
SEVERITY RATING:	Med.-Fair (Rec. to replace on next failure)

COMMENTS: No available record drawings. Service Life = 25 yrs.

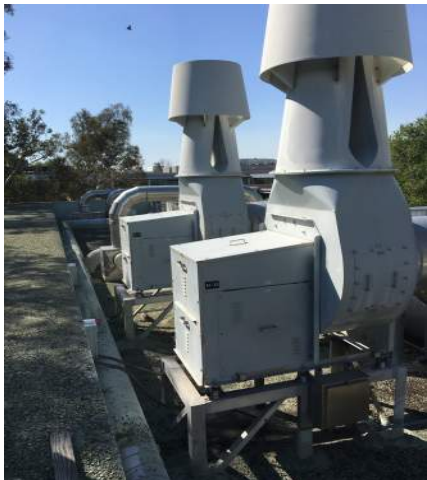
COMPONENT:	EF-10 fume exhaust
COMPONENT LOCATION:	Roof South Wing
AREA SERVED:	Fume exhaust
DATE OF INSTALLATION:	2000
REMAINING SERVICE LIFE:	5-10 yrs
OVERALL SEVERITY:	M
MANUFACTURER:	MK Plastic
SERIAL NO:	
MODEL NO:	
CAPACITY:	
ACTION REQUIRED:	Replace
SEVERITY RATING:	Med.-Fair (Rec. to replace on next failure)

COMMENTS: No available record drawings. Service Life = 25 yrs.

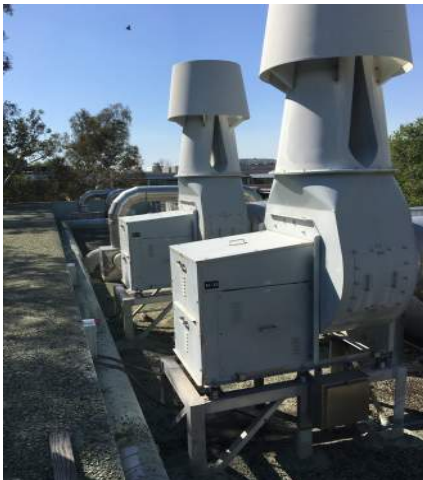
COMPONENT:	EF-11 fume exhaust
COMPONENT LOCATION:	Roof South Wing
AREA SERVED:	Fume exhaust
DATE OF INSTALLATION:	2000
REMAINING SERVICE LIFE:	5-10 yrs
OVERALL SEVERITY:	M
MANUFACTURER:	MK Plastic
SERIAL NO:	
MODEL NO:	
CAPACITY:	
ACTION REQUIRED:	Replace
SEVERITY RATING:	Med.-Fair (Rec. to replace on next failure)

COMMENTS: No available record drawings. Service Life = 25 yrs.

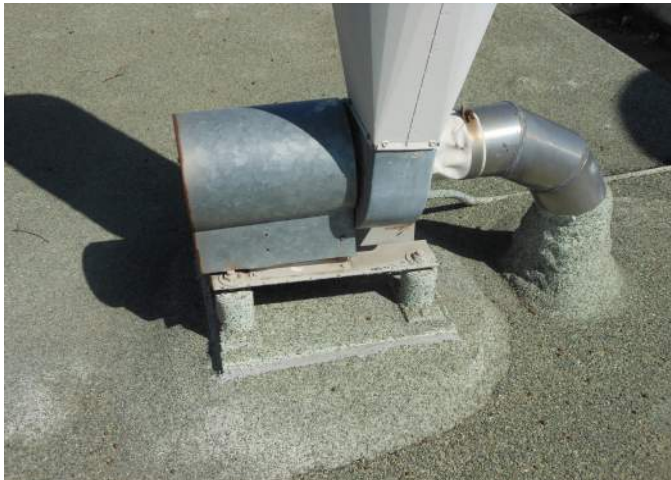
COMPONENT:	EF 3424 fume exhaust
COMPONENT LOCATION:	Roof North Wing
AREA SERVED:	Fume exhaust
DATE OF INSTALLATION:	1966
REMAINING SERVICE LIFE:	0 yrs
OVERALL SEVERITY:	H
MANUFACTURER:	MK Plastic
SERIAL NO:	
MODEL NO:	
CAPACITY:	
ACTION REQUIRED:	Replace
SEVERITY RATING:	High-Poor (Rec. replacement asap)

COMMENTS: No available record drawings. Service Life = 25 yrs.

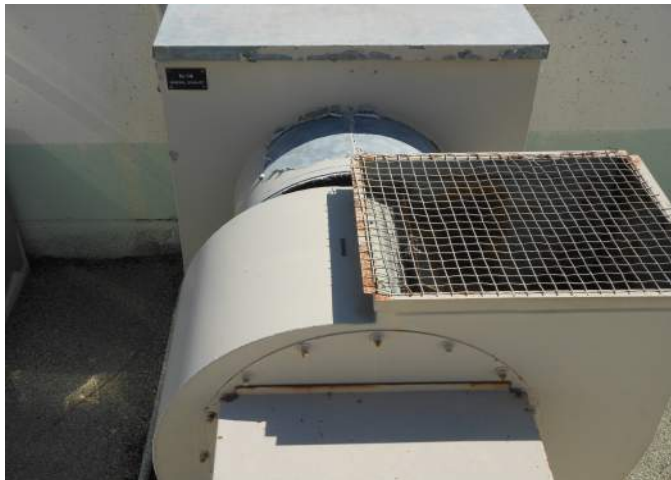
COMPONENT:	EF N-14 exhaust
COMPONENT LOCATION:	Roof North Wing
AREA SERVED:	General exhaust
DATE OF INSTALLATION:	1966
REMAINING SERVICE LIFE:	0 yrs
OVERALL SEVERITY:	H
MANUFACTURER:	MK Plastic
SERIAL NO:	
MODEL NO:	
CAPACITY:	
ACTION REQUIRED:	Replace
SEVERITY RATING:	High-Poor (Rec. replacement asap)

COMMENTS: No available record drawings. Service Life = 25 yrs.

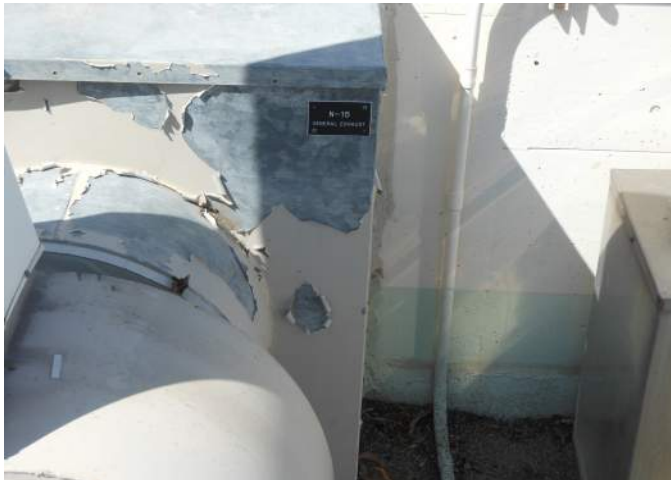
COMPONENT:	EF N-15 exhaust
COMPONENT LOCATION:	Roof North Wing
AREA SERVED:	General exhaust
DATE OF INSTALLATION:	1966
REMAINING SERVICE LIFE:	0 yrs
OVERALL SEVERITY:	H
MANUFACTURER:	GP Fan
SERIAL NO:	C-3798
MODEL NO:	222
CAPACITY:	
ACTION REQUIRED:	Replace
SEVERITY RATING:	High-Poor (Rec. replacement asap)

COMMENTS: No available record drawings. Service Life = 25 yrs.

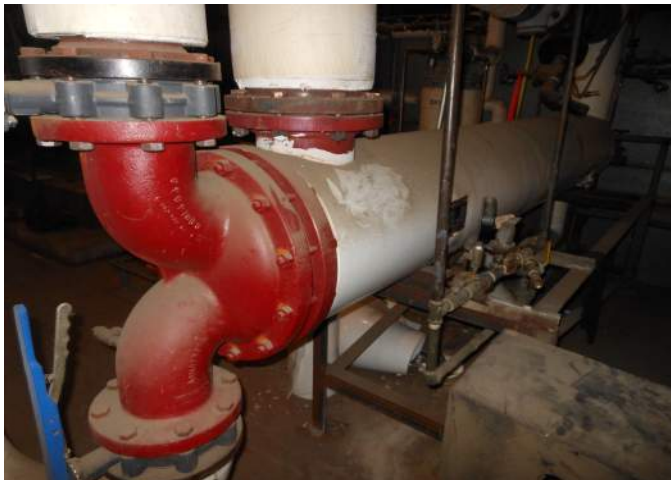
COMPONENT:	HE-1 Heat Exchanger
COMPONENT LOCATION:	B02
AREA SERVED:	Htg Hot Wat
DATE OF INSTALLATION:	2002
REMAINING SERVICE LIFE:	5-10 yrs
OVERALL SEVERITY:	M
MANUFACTURER:	Armstrong
SERIAL NO:	4686TS
MODEL NO:	WS-149-2-2
CAPACITY:	330 gpm
ACTION REQUIRED:	No Action Req'd
SEVERITY RATING:	Med.-Fair (Rec. to replace on next failure)

COMMENTS: GPM indicated per as-built drawing. Service Life = 24 yrs.

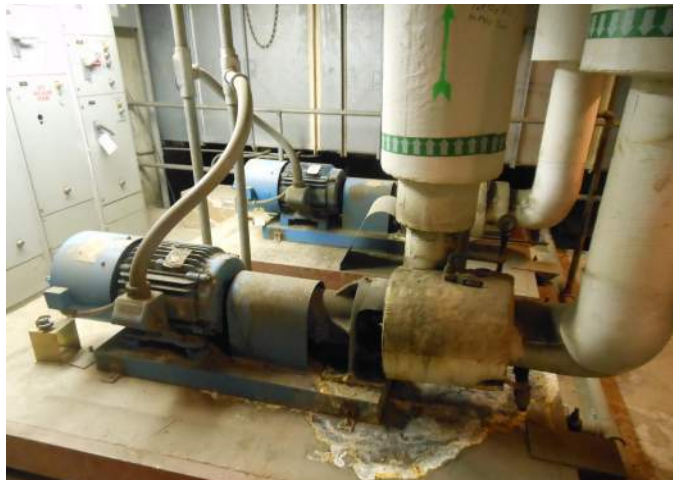
COMPONENT:	P-1 CHW pump
COMPONENT LOCATION:	B02
AREA SERVED:	Chilled Wat
DATE OF INSTALLATION:	1966
REMAINING SERVICE LIFE:	0 yrs
OVERALL SEVERITY:	H
MANUFACTURER:	PACO
SERIAL NO:	PRO#788-001852
MODEL NO:	
CAPACITY:	530 gpm
ACTION REQUIRED:	Replace
SEVERITY RATING:	High-Poor (Rec. replacement asap)

COMMENTS: 15 Hp, 200V/60Hz/3 Ph; GPM per as-built. Service Life = 20 yrs.

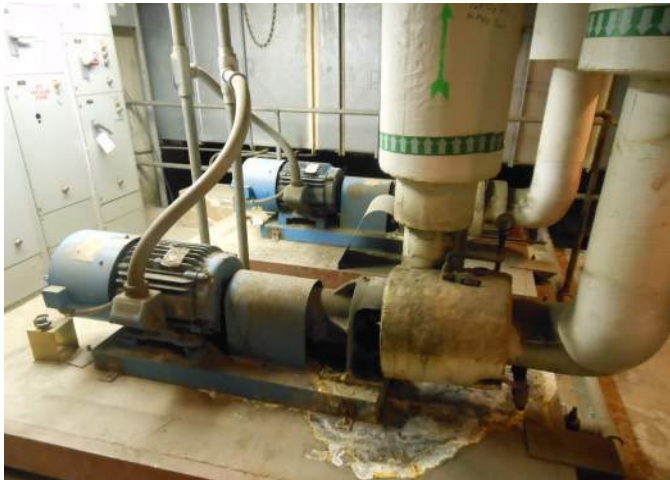
COMPONENT:	P-2 CHW pump
COMPONENT LOCATION:	B02
AREA SERVED:	Chilled Wat
DATE OF INSTALLATION:	1966
REMAINING SERVICE LIFE:	0 yrs
OVERALL SEVERITY:	H
MANUFACTURER:	PACO
SERIAL NO:	PRO#788-001852
MODEL NO:	
CAPACITY:	530 gpm
ACTION REQUIRED:	Replace
SEVERITY RATING:	High-Poor (Rec. replacement asap)

COMMENTS: 15 Hp, 200V/60Hz/3 Ph; GPM per as-built. Service Life = 20 yrs.

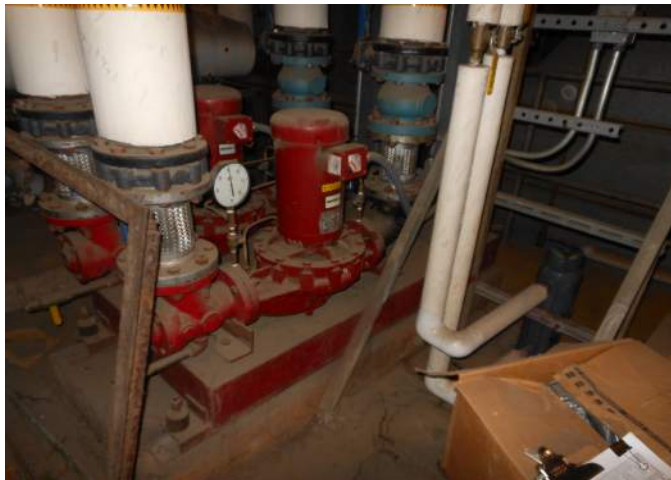
COMPONENT:	P-3 HHW pump
COMPONENT LOCATION:	B02
AREA SERVED:	Htg Hot Wat
DATE OF INSTALLATION:	2002
REMAINING SERVICE LIFE:	5-10 yrs
OVERALL SEVERITY:	M
MANUFACTURER:	Peerless
SERIAL NO:	
MODEL NO:	3x3 4380
CAPACITY:	165 gpm
ACTION REQUIRED:	Repair
SEVERITY RATING:	Med.-Fair (Rec. to replace on next failure)

COMMENTS: GPM indicated per as-built drawing. Service Life = 20 yrs.

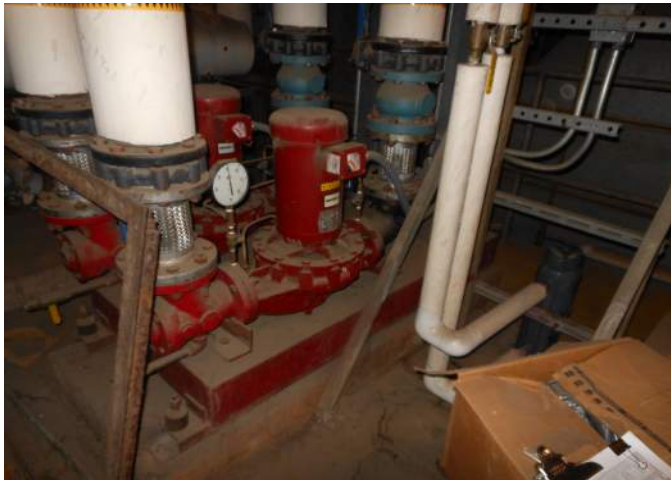
COMPONENT:	P-4 HHW pump
COMPONENT LOCATION:	B02
AREA SERVED:	Htg Hot Wat
DATE OF INSTALLATION:	2002
REMAINING SERVICE LIFE:	5-10 yrs
OVERALL SEVERITY:	M
MANUFACTURER:	Peerless
SERIAL NO:	
MODEL NO:	3x3 4380
CAPACITY:	165 gpm
ACTION REQUIRED:	Repair
SEVERITY RATING:	Med.-Fair (Rec. to replace on next failure)

COMMENTS: GPM indicated per as-built drawing. Service Life = 20 yrs.

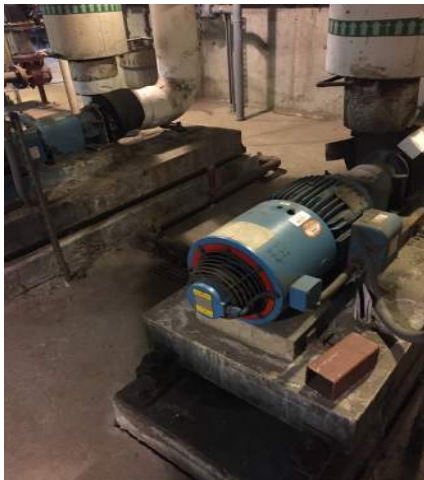
COMPONENT:	P-5 CHW pump
COMPONENT LOCATION:	Basement North Wing
AREA SERVED:	Chilled Wat
DATE OF INSTALLATION:	1966
REMAINING SERVICE LIFE:	0 yrs
OVERALL SEVERITY:	H
MANUFACTURER:	
SERIAL NO:	
MODEL NO:	
CAPACITY:	
ACTION REQUIRED:	Replace
SEVERITY RATING:	High-Poor (Rec. replacement asap)

COMMENTS: No available record drawings. Service Life = 20 yrs.

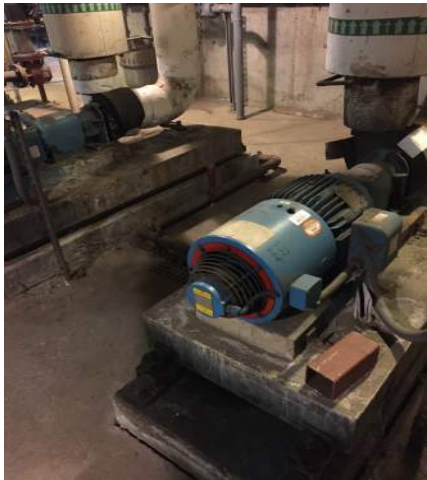
COMPONENT:	P-6 CHW pump
COMPONENT LOCATION:	Basement North Wing
AREA SERVED:	Chilled Wat
DATE OF INSTALLATION:	1966
REMAINING SERVICE LIFE:	0 yrs
OVERALL SEVERITY:	H
MANUFACTURER:	
SERIAL NO:	
MODEL NO:	
CAPACITY:	
ACTION REQUIRED:	Replace
SEVERITY RATING:	High-Poor (Rec. replacement asap)

COMMENTS: No available record drawings. Service Life = 20 yrs.

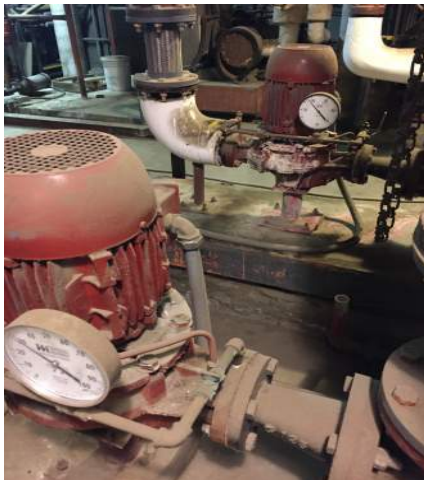
COMPONENT:	P-7 HHW pump
COMPONENT LOCATION:	Basement North Wing
AREA SERVED:	Htg Hot Wat
DATE OF INSTALLATION:	1966
REMAINING SERVICE LIFE:	0 yrs
OVERALL SEVERITY:	H
MANUFACTURER:	
SERIAL NO:	
MODEL NO:	
CAPACITY:	
ACTION REQUIRED:	Replace
SEVERITY RATING:	High-Poor (Rec. replacement asap)

COMMENTS: No available record drawings. Service Life = 20 yrs.

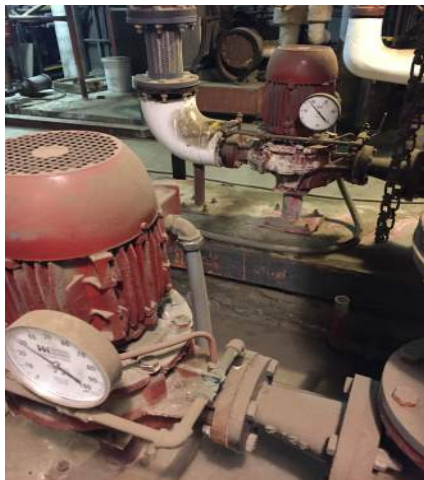
COMPONENT:	P-8 HHW pump
COMPONENT LOCATION:	Basement North Wing
AREA SERVED:	Htg Hot Wat
DATE OF INSTALLATION:	1966
REMAINING SERVICE LIFE:	0 yrs
OVERALL SEVERITY:	H
MANUFACTURER:	
SERIAL NO:	
MODEL NO:	
CAPACITY:	
ACTION REQUIRED:	Replace
SEVERITY RATING:	High-Poor (Rec. replacement asap)

COMMENTS: No available record drawings. Service Life = 20 yrs.

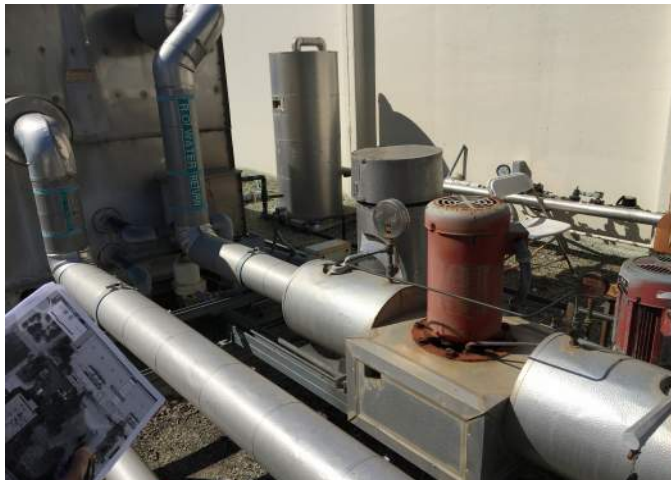
COMPONENT:	P-8 RO Pump
COMPONENT LOCATION:	
AREA SERVED:	
DATE OF INSTALLATION:	
REMAINING SERVICE LIFE:	
OVERALL SEVERITY:	
MANUFACTURER:	
SERIAL NO:	
MODEL NO:	
CAPACITY:	
ACTION REQUIRED:	
SEVERITY RATING:

COMMENTS: Abandoned - To be Demolished

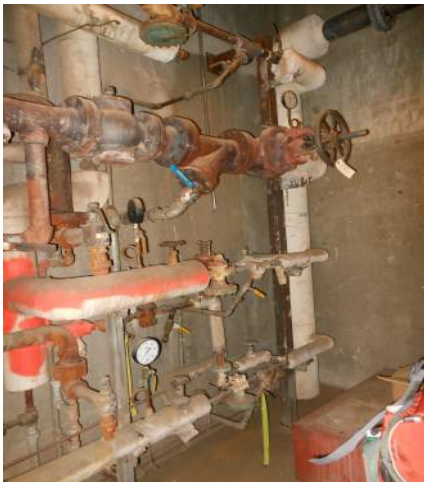
COMPONENT:	PRV-1
COMPONENT LOCATION:	B02
AREA SERVED:	Steam Syst
DATE OF INSTALLATION:	1966
REMAINING SERVICE LIFE:	0 yrs
OVERALL SEVERITY:	H
MANUFACTURER:	
SERIAL NO:	
MODEL NO:	
CAPACITY:	1,800 lbs/hr
ACTION REQUIRED:	Replace
SEVERITY RATING:	High-Poor (Rec. replacement asap)

COMMENTS: lbs/hr indicated per as-built drawing. Service Life = 30 yrs.

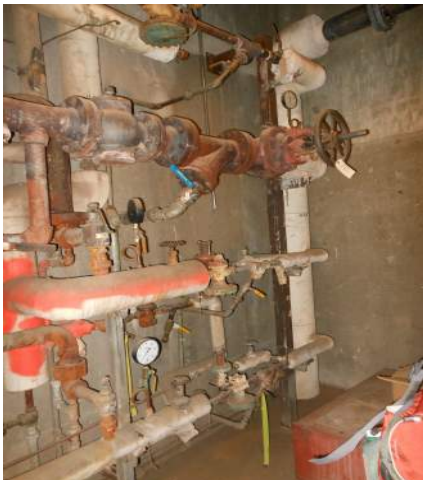
COMPONENT:	PRV-2
COMPONENT LOCATION:	B02
AREA SERVED:	Steam Syst
DATE OF INSTALLATION:	1966
REMAINING SERVICE LIFE:	0 yrs
OVERALL SEVERITY:	H
MANUFACTURER:	
SERIAL NO:	
MODEL NO:	
CAPACITY:	3,150 lbs/hr
ACTION REQUIRED:	Replace
SEVERITY RATING:	High-Poor (Rec. replacement asap)

COMMENTS: lbs/hr indicated per as-built drawing. Service Life = 30 yrs.

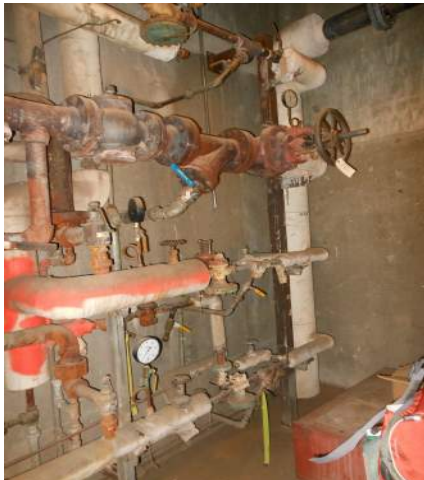
COMPONENT:	PRV-3
COMPONENT LOCATION:	B02
AREA SERVED:	Steam Syst
DATE OF INSTALLATION:	1966
REMAINING SERVICE LIFE:	0 yrs
OVERALL SEVERITY:	H
MANUFACTURER:	
SERIAL NO:	
MODEL NO:	
CAPACITY:	6,200 lbs/hr
ACTION REQUIRED:	Replace
SEVERITY RATING:	High-Poor (Rec. replacement asap)

COMMENTS: lbs/hr indicated per as-built drawing. Service Life = 30 yrs.

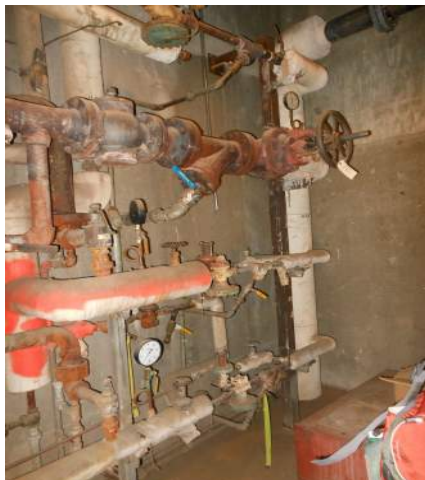
COMPONENT:	PRV-4
COMPONENT LOCATION:	B02
AREA SERVED:	Steam Syst
DATE OF INSTALLATION:	1966
REMAINING SERVICE LIFE:	0 yrs
OVERALL SEVERITY:	H
MANUFACTURER:	
SERIAL NO:	
MODEL NO:	
CAPACITY:	540 lbs/hr
ACTION REQUIRED:	Replace
SEVERITY RATING:	High-Poor (Rec. replacement asap)

COMMENTS: lbs/hr indicated per as-built drawing. Service Life = 30 yrs.
