PIERCE HALL IMPROVEMENTS & INTERIOR IMPROVEMENTS

UCR PROJECT NOS. 950511 & 950532

RBB ARCHITECTS INC

11/01/2016

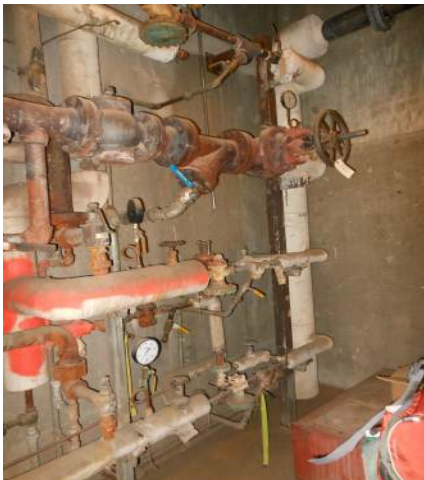
COMPONENT:	PRV-5
COMPONENT LOCATION:	B02
AREA SERVED:	Steam Syst
DATE OF INSTALLATION:	1966
REMAINING SERVICE LIFE:	0 yrs
OVERALL SEVERITY:	H
MANUFACTURER:	
SERIAL NO:	
MODEL NO:	
CAPACITY:	220 lbs/hr
ACTION REQUIRED:	Replace
SEVERITY RATING:	High-Poor (Rec. replacement asap)

COMMENTS: lbs/hr indicated per as-built drawing. Service Life = 30 yrs.

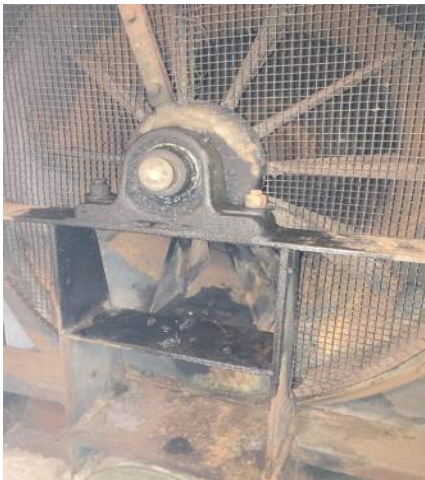
COMPONENT:	S-1 Fan
COMPONENT LOCATION:	B05
AREA SERVED:	South Wing
DATE OF INSTALLATION:	1966
REMAINING SERVICE LIFE:	0 yrs
OVERALL SEVERITY:	H
MANUFACTURER:	Trane
SERIAL NO:	
MODEL NO:	40-AF-ARR-3
CAPACITY:	33,000 CFM
ACTION REQUIRED:	Replace
SEVERITY RATING:	High-Poor (Rec. replacement asap)

COMMENTS: Capacity indicated per as-built drawing. Service Life = 25 yrs.

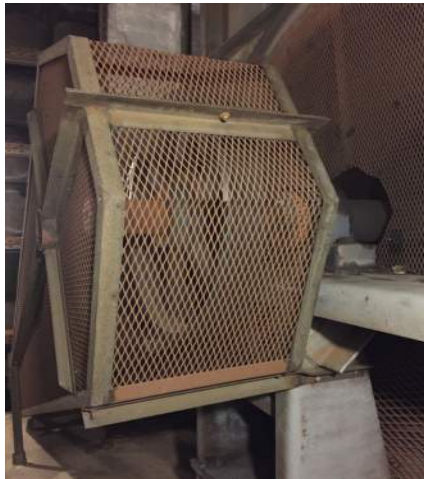
COMPONENT:	S-2 Fan
COMPONENT LOCATION:	B02
AREA SERVED:	Central Area
DATE OF INSTALLATION:	1966
REMAINING SERVICE LIFE:	0 yrs
OVERALL SEVERITY:	H
MANUFACTURER:	Trane
SERIAL NO:	
MODEL NO:	60-AF-ARR-3
CAPACITY:	88,000 CFM
ACTION REQUIRED:	Replace
SEVERITY RATING:	High-Poor (Rec. replacement asap)

COMMENTS: Capacity indicated per as-built drawing. Service Life = 25 yrs.

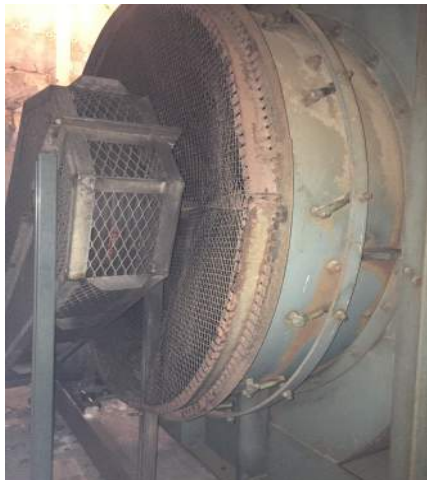
COMPONENT:	S-3 Fan
COMPONENT LOCATION:	Basement North Wing
AREA SERVED:	North Wing
DATE OF INSTALLATION:	1966
REMAINING SERVICE LIFE:	0 yrs
OVERALL SEVERITY:	H
MANUFACTURER:	
SERIAL NO:	
MODEL NO:	
CAPACITY:	60,000 CFM
ACTION REQUIRED:	Replace
SEVERITY RATING:	High-Poor (Rec. replacement asap)

COMMENTS: No available record drawings. Service Life = 25 yrs.

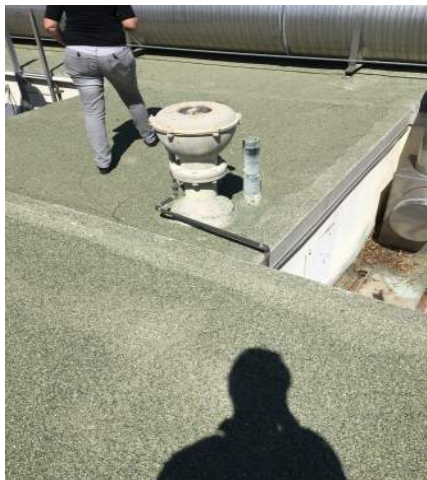
COMPONENT:	Steam Vent - No Tag
COMPONENT LOCATION:	Roof North Wing
AREA SERVED:	Steam Syst
DATE OF INSTALLATION:	1966
REMAINING SERVICE LIFE:	0 yrs
OVERALL SEVERITY:	H
MANUFACTURER:	
SERIAL NO:	
MODEL NO:	
CAPACITY:	
ACTION REQUIRED:	
SEVERITY RATING:	High-Poor (Rec. replacement asap)

COMMENTS: Service Life = 30 yrs.

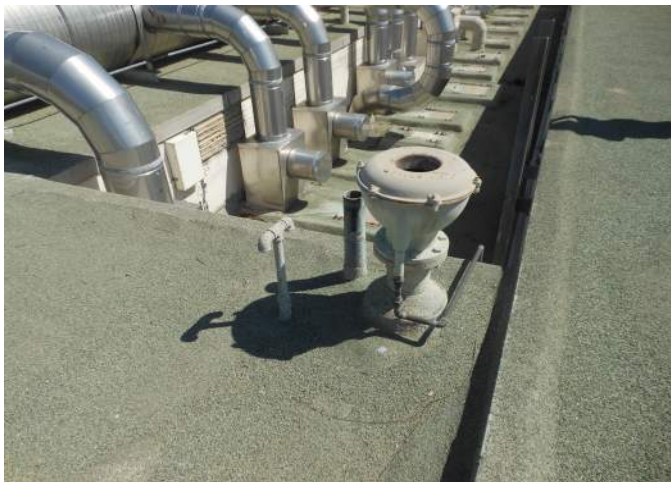
COMPONENT:	Steam Vent - No Tag
COMPONENT LOCATION:	Roof North Wing
AREA SERVED:	Steam Syst
DATE OF INSTALLATION:	1966
REMAINING SERVICE LIFE:	0 yrs
OVERALL SEVERITY:	H
MANUFACTURER:	
SERIAL NO:	
MODEL NO:	
CAPACITY:	
ACTION REQUIRED:	
SEVERITY RATING:	High-Poor (Rec. replacement asap)

COMMENTS: Service Life = 30 yrs.

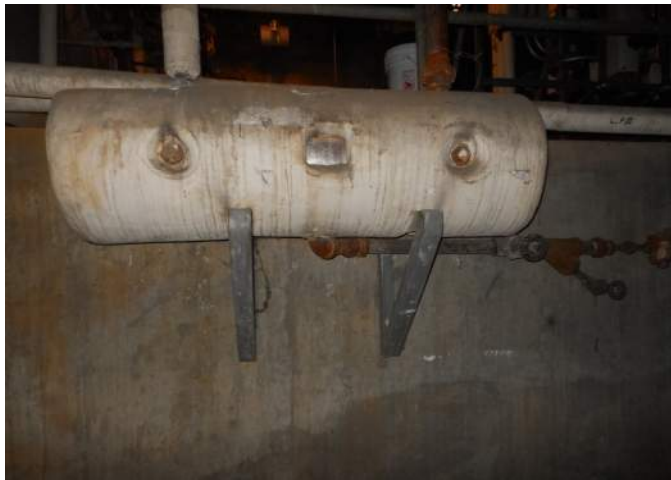
COMPONENT:	T-1 Hot Wat Tank
COMPONENT LOCATION:	B02
AREA SERVED:	Htg Hot Wat
DATE OF INSTALLATION:	1966
REMAINING SERVICE LIFE:	0 yrs
OVERALL SEVERITY:	H
MANUFACTURER:	Advance Tank
SERIAL NO:	15381
MODEL NO:	Horizontal
CAPACITY:	90 gal
ACTION REQUIRED:	Replace
SEVERITY RATING:	High-Poor (Rec. replacement asap)

COMMENTS: Service Life = 30 yrs.

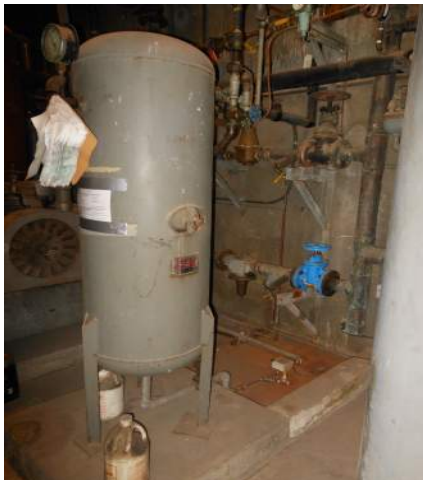
COMPONENT:	T-2 Control Air Tank
COMPONENT LOCATION:	B02
AREA SERVED:	HVAC Controls
DATE OF INSTALLATION:	1966
REMAINING SERVICE LIFE:	0 yrs
OVERALL SEVERITY:	H
MANUFACTURER:	Advance Tank
SERIAL NO:	15362
MODEL NO:	Vertical
CAPACITY:	60 gal
ACTION REQUIRED:	Replace
SEVERITY RATING:	High-Poor (Rec. replacement asap)

COMMENTS: Remaining pneumatic controls to be demolished. All HVAC controls shall be DDC.

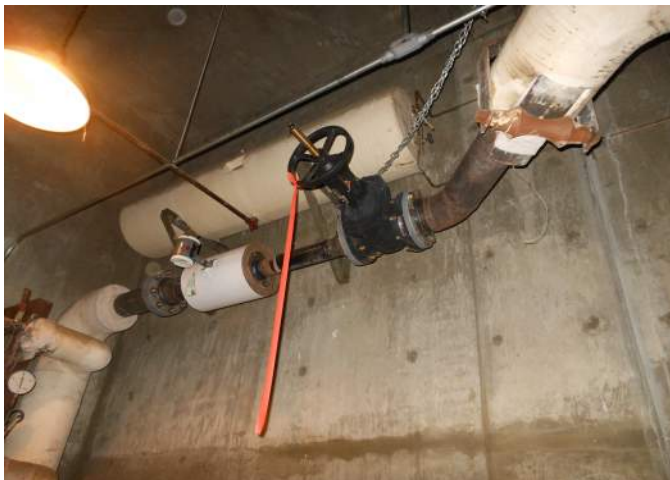
COMPONENT:	T-3 Flash Tank
COMPONENT LOCATION:	B02
AREA SERVED:	Steam Syst
DATE OF INSTALLATION:	1966
REMAINING SERVICE LIFE:	0 yrs
OVERALL SEVERITY:	H
MANUFACTURER:	
SERIAL NO:	
MODEL NO:	Horizontal
CAPACITY:	
ACTION REQUIRED:	Replace
SEVERITY RATING:	High-Poor (Rec. replacement asap)

COMMENTS: No available record drawings. Service Life = 30 yrs.

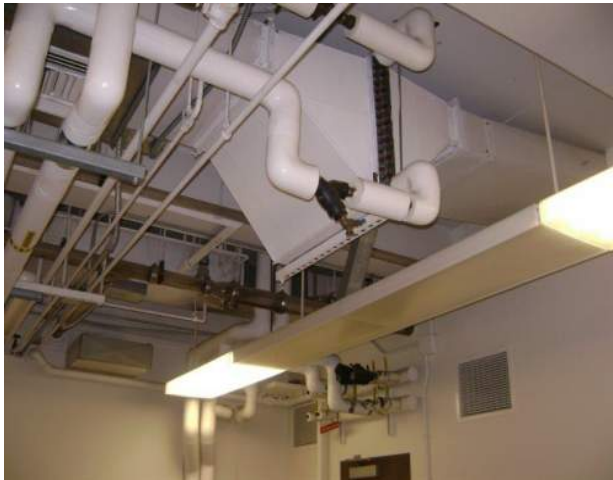
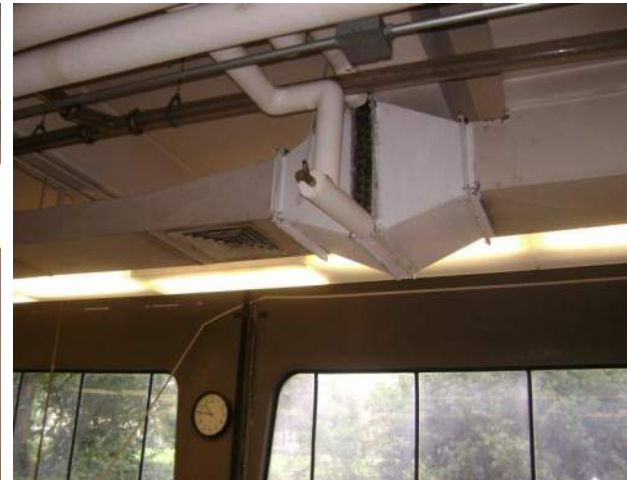
COMPONENT:	Terminal Reheat Coils
COMPONENT LOCATION:	Various Zones
AREA SERVED:	Various Zones
DATE OF INSTALLATION:	2000
REMAINING SERVICE LIFE:	5-10 yrs
OVERALL SEVERITY:	M
MANUFACTURER:	
SERIAL NO:	
MODEL NO:	
CAPACITY:	
ACTION REQUIRED:	Repair
SEVERITY RATING:	Med.-Fair (Rec. to replace on next failure)

COMMENTS: No available record drawings. Service Life = 20 yrs.

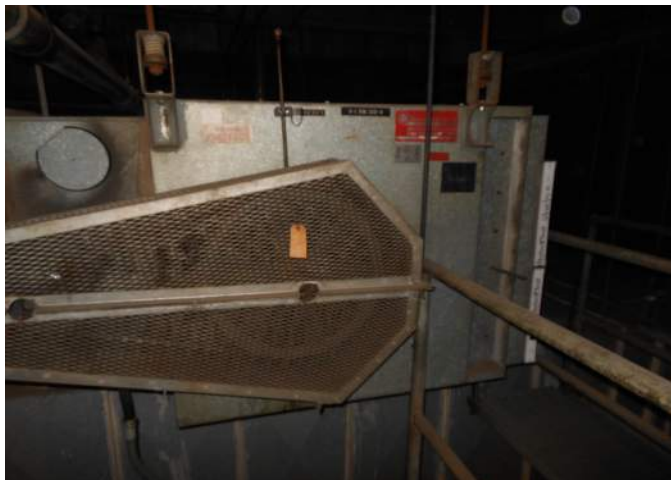
COMPONENT:	V-1 Fan
COMPONENT LOCATION:	B05
AREA SERVED:	Elec Rm 304
DATE OF INSTALLATION:	1966
REMAINING SERVICE LIFE:	0 yrs
OVERALL SEVERITY:	H
MANUFACTURER:	American St.
SERIAL NO:	H
MODEL NO:	2V18
CAPACITY:	10,000 CFM
ACTION REQUIRED:	Replace
SEVERITY RATING:	High-Poor (Rec. replacement asap)

COMMENTS: Capacity indicated per as-built drawing. Service Life = 25 yrs.

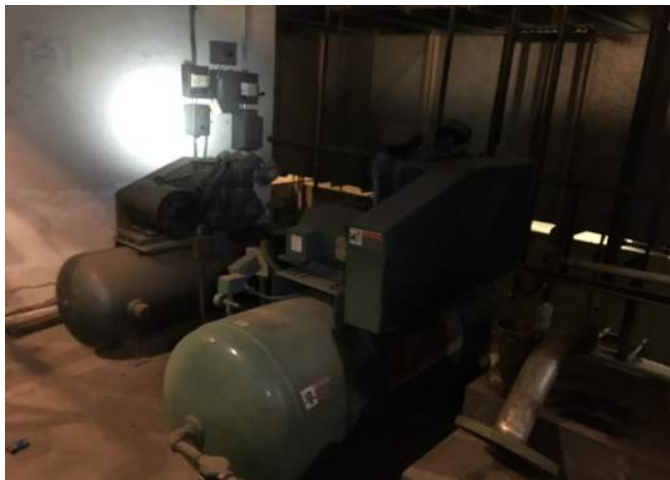
COMPONENT:	Air Compressor #1
COMPONENT LOCATION:	Equip Rm B02
AREA SERVED:	Comp Air
DATE OF INSTALLATION:	
REMAINING SERVICE LIFE:	
OVERALL SEVERITY:	H
MANUFACTURER:	Speed Air
SERIAL NO:	
MODEL NO:	37180
CAPACITY:	
ACTION REQUIRED:	Replace
SEVERITY RATING:	High-Poor (Rec. replacement asap)

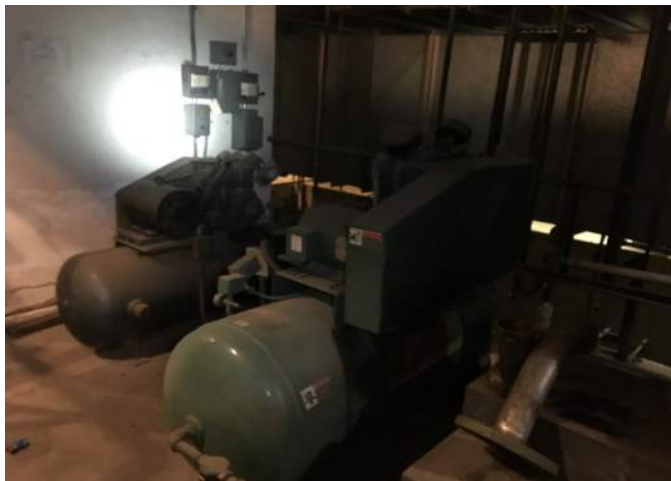
COMPONENT:	Air Compressor #2
COMPONENT LOCATION:	Equip Rm B02
AREA SERVED:	Comp Air
DATE OF INSTALLATION:	
REMAINING SERVICE LIFE:	
OVERALL SEVERITY:	H
MANUFACTURER:	Champion
SERIAL NO:	
MODEL NO:	HR10-12
CAPACITY:	
ACTION REQUIRED:	Replace
SEVERITY RATING:	High-Poor (Rec. replacement asap)

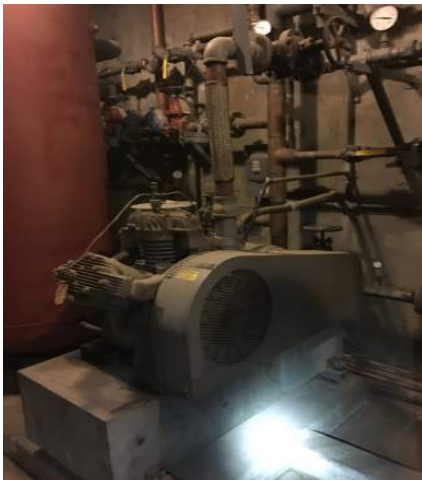
COMPONENT:	Air Compressor
COMPONENT LOCATION:	Equip Rm B02
AREA SERVED:	Comp Air
DATE OF INSTALLATION:	1964
REMAINING SERVICE LIFE:	0 yrs
OVERALL SEVERITY:	H
MANUFACTURER:	
SERIAL NO:	
MODEL NO:	
CAPACITY:	15 hp
ACTION REQUIRED:	Replace
SEVERITY RATING:	High-Poor (Rec. replacement asap)

COMMENTS: Capacity indicated per as-built drawing. 20 Hp 256T

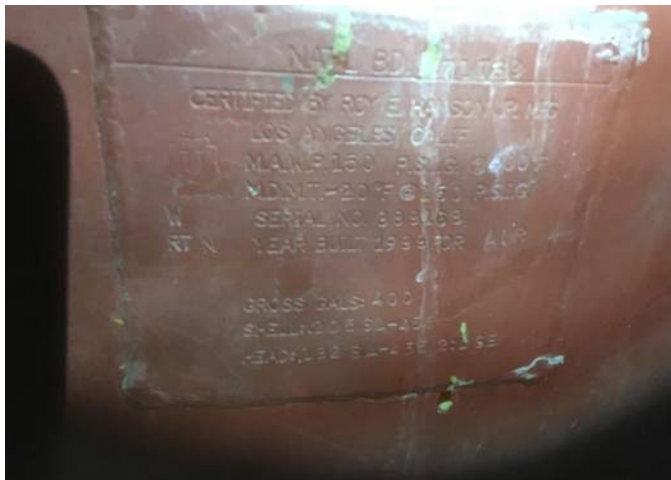
COMPONENT:	AT-1 Air Tank
COMPONENT LOCATION:	Equip Rm B02
AREA SERVED:	Comp Air
DATE OF INSTALLATION:	1964
REMAINING SERVICE LIFE:	0 yrs
OVERALL SEVERITY:	H
MANUFACTURER:	
SERIAL NO:	
MODEL NO:	
CAPACITY:	400 gal
ACTION REQUIRED:	Replace
SEVERITY RATING:	High-Poor (Rec. replacement asap)

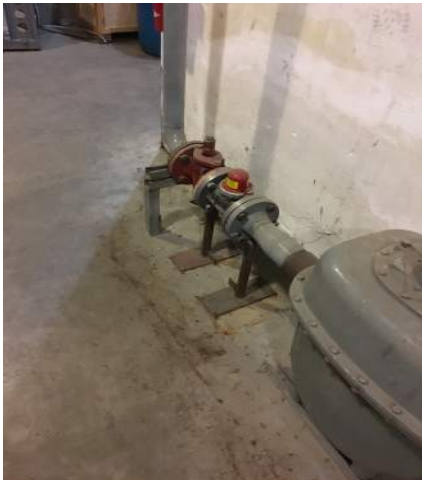
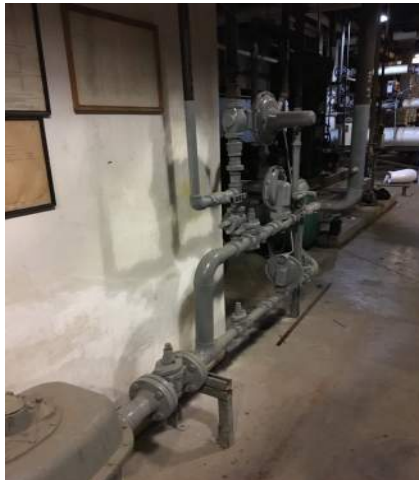
COMPONENT:	Gas meter
COMPONENT LOCATION:	Equip Rm B02
AREA SERVED:	Gas Sys
DATE OF INSTALLATION:	
REMAINING SERVICE LIFE:	0 yrs
OVERALL SEVERITY:	H
MANUFACTURER:	
SERIAL NO:	
MODEL NO:	
CAPACITY:	2 1/2" 2psi
ACTION REQUIRED:	Replace
SEVERITY RATING:	High-Poor (Rec. replacement asap)

COMMENTS: Per Facility meter does not work.

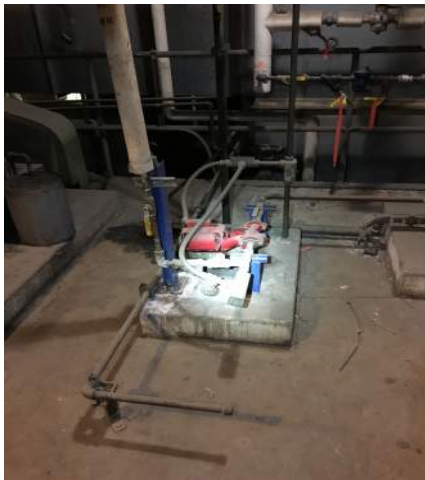
COMPONENT:	P-1 Dom HW Ret Pump
COMPONENT LOCATION:	Equip Rm B02
AREA SERVED:	Hot Wat Ret
DATE OF INSTALLATION:	1964
REMAINING SERVICE LIFE:	0 yrs
OVERALL SEVERITY:	H
MANUFACTURER:	B&G
SERIAL NO:	106189
MODEL NO:	Series 100 L50
CAPACITY:	5 gpm
ACTION REQUIRED:	Replace
SEVERITY RATING:	High-Poor (Rec. replacement asap)

COMMENTS: Capacity indicated per as-built drawing. 1/12Hp 115V 1.75A

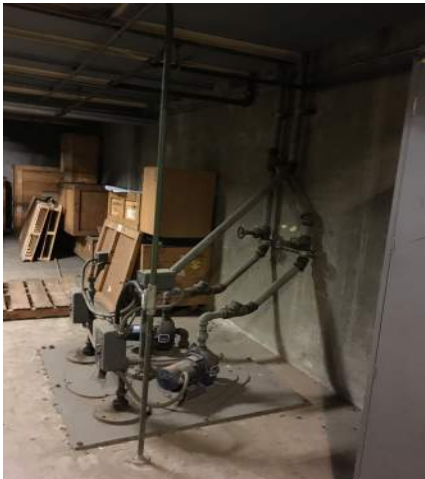
COMPONENT:	P-2 Sump Pump
COMPONENT LOCATION:	Equip Rm B02
AREA SERVED:	San Waste
DATE OF INSTALLATION:	1964
REMAINING SERVICE LIFE:	0 yrs
OVERALL SEVERITY:	H
MANUFACTURER:	Gorman Rupp
SERIAL NO:	1088022
MODEL NO:	81
CAPACITY:	50 gpm
ACTION REQUIRED:	Replace
SEVERITY RATING:	High-Poor (Rec. replacement asap)

COMMENTS: Capacity indicated per as-built drawing. 1/2Hp 3450 RPM

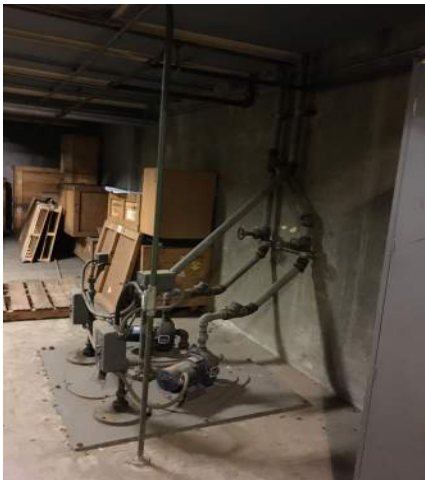
COMPONENT:	P-3 Sump Pump
COMPONENT LOCATION:	Equip Rm B02
AREA SERVED:	San Waste
DATE OF INSTALLATION:	1964
REMAINING SERVICE LIFE:	0 yrs
OVERALL SEVERITY:	H
MANUFACTURER:	Gorman Rupp
SERIAL NO:	915806
MODEL NO:	81
CAPACITY:	50 gpm
ACTION REQUIRED:	Replace
SEVERITY RATING:	High-Poor (Rec. replacement asap)

COMMENTS: Capacity indicated per as-built drawing. 1/2Hp 3450 RPM

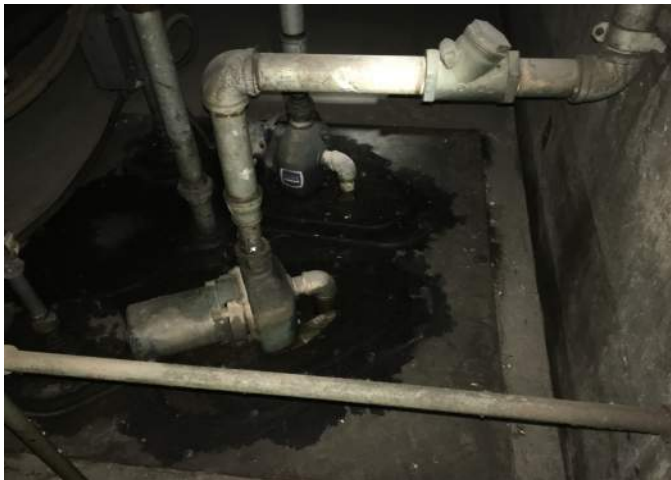
COMPONENT:	P-4 Sump Pump
COMPONENT LOCATION:	Equip Rm B05
AREA SERVED:	Storm Drain
DATE OF INSTALLATION:	1964
REMAINING SERVICE LIFE:	0 yrs
OVERALL SEVERITY:	H
MANUFACTURER:	Gorman Rupp
SERIAL NO:	595199
MODEL NO:	81
CAPACITY:	50 gpm
ACTION REQUIRED:	Replace
SEVERITY RATING:	High-Poor (Rec. replacement asap)

COMMENTS: Capacity indicated per as-built drawing.

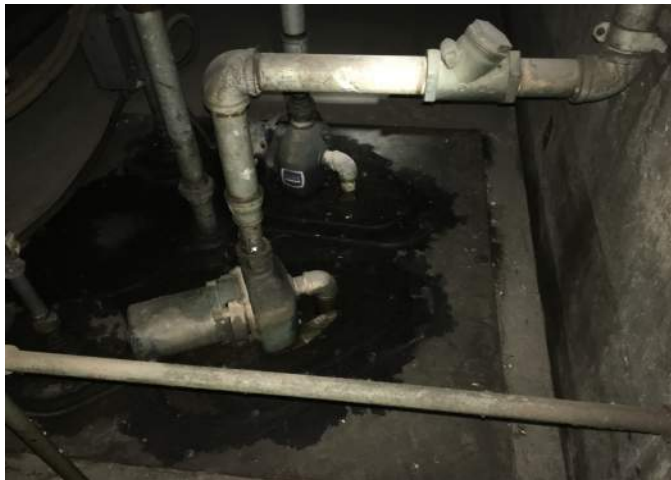
COMPONENT:	P-5 Sump Pump
COMPONENT LOCATION:	Equip Rm B05
AREA SERVED:	Storm Drain
DATE OF INSTALLATION:	1964
REMAINING SERVICE LIFE:	0 yrs
OVERALL SEVERITY:	H
MANUFACTURER:	Gorman Rupp
SERIAL NO:	465328
MODEL NO:	81
CAPACITY:	50 gpm
ACTION REQUIRED:	Replace
SEVERITY RATING:	High-Poor (Rec. replacement asap)

COMMENTS: Capacity indicated per as-built drawing.

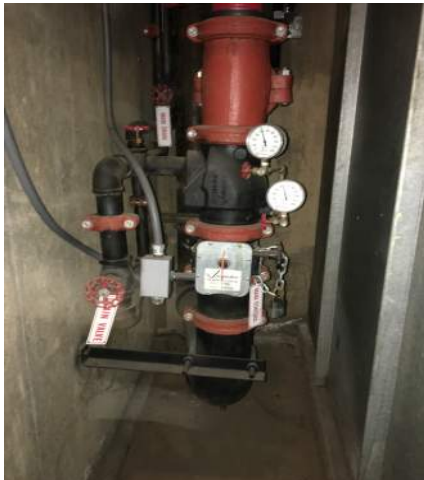
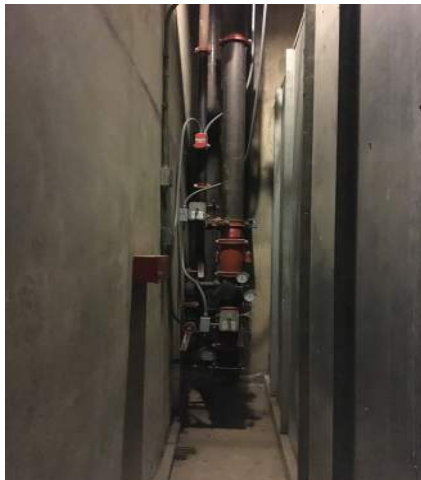
COMPONENT:	Sprinkler Main
COMPONENT LOCATION:	Equip Rm B05
AREA SERVED:	Fire Riser
DATE OF INSTALLATION:	
REMAINING SERVICE LIFE:	
OVERALL SEVERITY:	M
MANUFACTURER:	
SERIAL NO:	
MODEL NO:	
CAPACITY:	4"
ACTION REQUIRED:	No Action Req'd
SEVERITY RATING:	Med.-Fair (Rec. to replace on next failure)

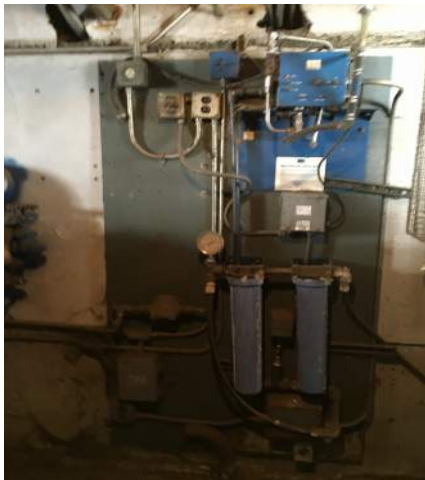
COMPONENT:	ST-1 Still
COMPONENT LOCATION:	Penthouse
AREA SERVED:	Distilled Wat
DATE OF INSTALLATION:	1964
REMAINING SERVICE LIFE:	0 yrs
OVERALL SEVERITY:	H
MANUFACTURER:	
SERIAL NO:	
MODEL NO:	
CAPACITY:	240 gph
ACTION REQUIRED:	Replace
SEVERITY RATING:	High-Poor (Rec. replacement asap)

COMMENTS: Capacity indicated per as-built drawing. Observed not working.

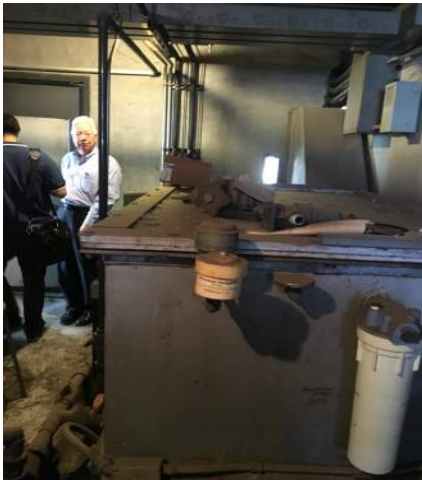
COMPONENT:	Still tank
COMPONENT LOCATION:	Penthouse
AREA SERVED:	Distilled Wat
DATE OF INSTALLATION:	1964
REMAINING SERVICE LIFE:	0 yrs
OVERALL SEVERITY:	H
MANUFACTURER:	
SERIAL NO:	
MODEL NO:	
CAPACITY:	300 gal
ACTION REQUIRED:	Replace
SEVERITY RATING:	High-Poor (Rec. replacement asap)

COMMENTS: Capacity indicated per as-built drawing. Observed not working.

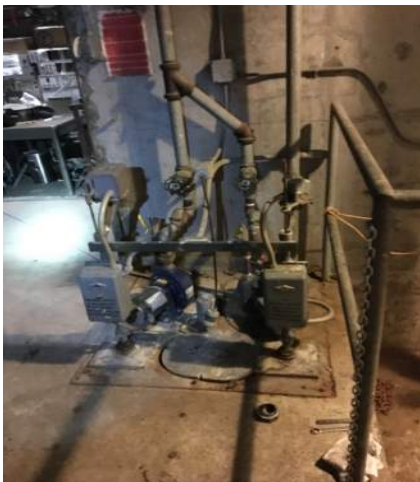
COMPONENT:	Sump Pump
COMPONENT LOCATION:	North Wing
AREA SERVED:	Storm Drain
DATE OF INSTALLATION:	1965
REMAINING SERVICE LIFE:	0 yrs
OVERALL SEVERITY:	H
MANUFACTURER:	Gorman Rupp
SERIAL NO:	712193
MODEL NO:	81
CAPACITY:	
ACTION REQUIRED:	Replace
SEVERITY RATING:	High-Poor (Rec. replacement asap)

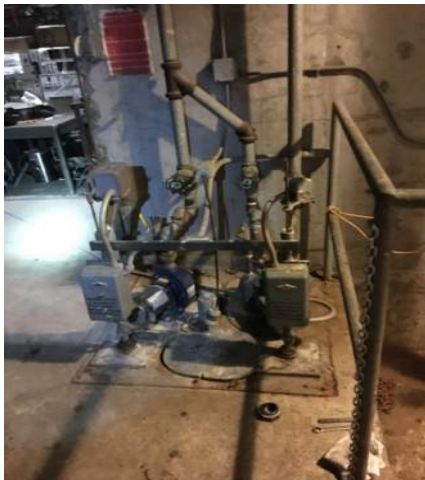
COMPONENT:	Sump Pump
COMPONENT LOCATION:	North Wing
AREA SERVED:	Storm Drain
DATE OF INSTALLATION:	1965
REMAINING SERVICE LIFE:	0 yrs
OVERALL SEVERITY:	H
MANUFACTURER:	Gorman Rupp
SERIAL NO:	712192
MODEL NO:	81
CAPACITY:	
ACTION REQUIRED:	Replace
SEVERITY RATING:	High-Poor (Rec. replacement asap)

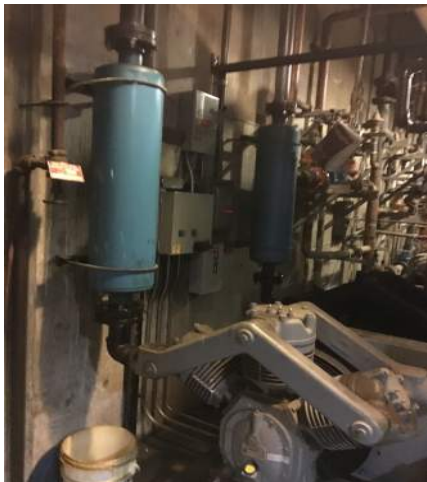
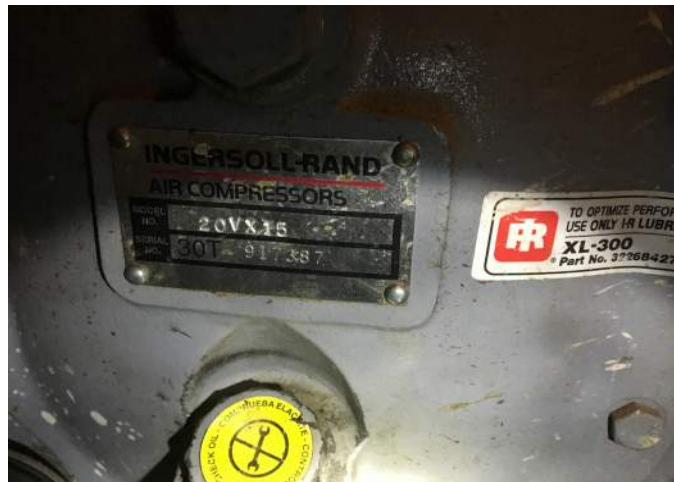
COMPONENT:	VC-1 Vacuum Pump
COMPONENT LOCATION:	Equip Rm B02
AREA SERVED:	Vac syst
DATE OF INSTALLATION:	1964
REMAINING SERVICE LIFE:	0 yrs
OVERALL SEVERITY:	H
MANUFACTURER:	IR
SERIAL NO:	30T 917387
MODEL NO:	20VX15
CAPACITY:	15 hp
ACTION REQUIRED:	Replace
SEVERITY RATING:	High-Poor (Rec. replacement asap)

COMMENTS: (2) vac pumps seen.

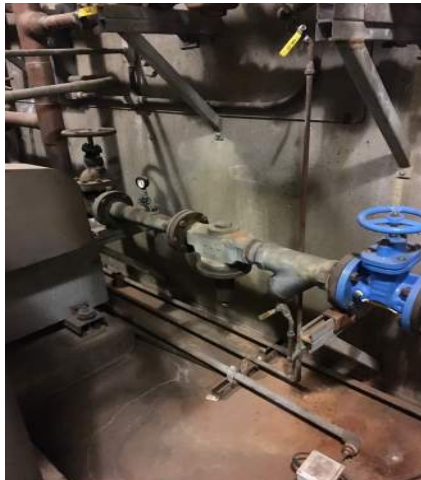
COMPONENT:	Water meter
COMPONENT LOCATION:	Equip Rm B02
AREA SERVED:	Dom Wat
DATE OF INSTALLATION:	1964
REMAINING SERVICE LIFE:	0 yrs
OVERALL SEVERITY:	H
MANUFACTURER:	
SERIAL NO:	
MODEL NO:	
CAPACITY:	4" conn
ACTION REQUIRED:	Replace
SEVERITY RATING:	High-Poor (Rec. replacement asap)

COMMENTS: Per Facility meter does not work.

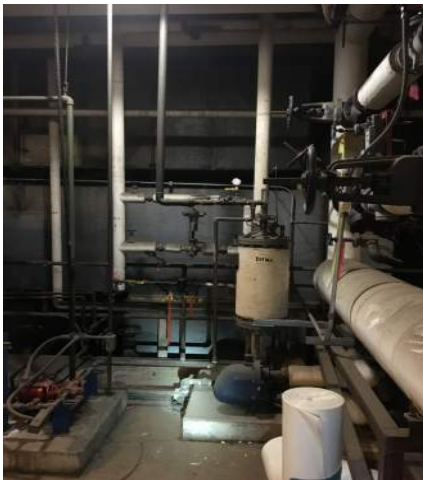
COMPONENT:	WH-1 Water Heater
COMPONENT LOCATION:	Equip Rm B02
AREA SERVED:	Hot Wat Sys
DATE OF INSTALLATION:	1964
REMAINING SERVICE LIFE:	0 yrs
OVERALL SEVERITY:	H
MANUFACTURER:	AERCO
SERIAL NO:	
MODEL NO:	1001
CAPACITY:	2.5 gpm
ACTION REQUIRED:	Replace
SEVERITY RATING:	High-Poor (Rec. replacement asap)
